# PLAY AREA SAFETY INSPECTION REPORT

## Chideock Parish Council

Park Name: Mill Lane  
Location: Mill Lane, Chideock. DT6 6JS

Inspection undertaken December 2023  
This report issued 22<sup>nd</sup> January 2024

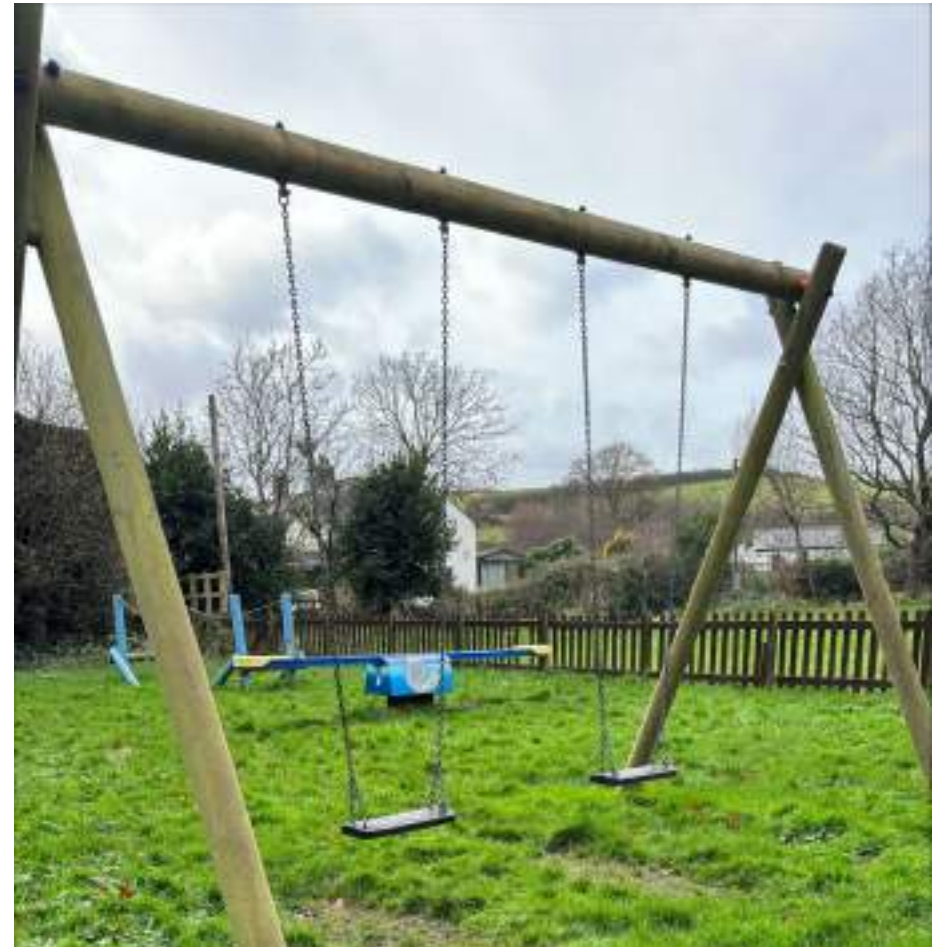
#### 4.1 *Twin Junior Swing Set*

This item is in reasonable condition.

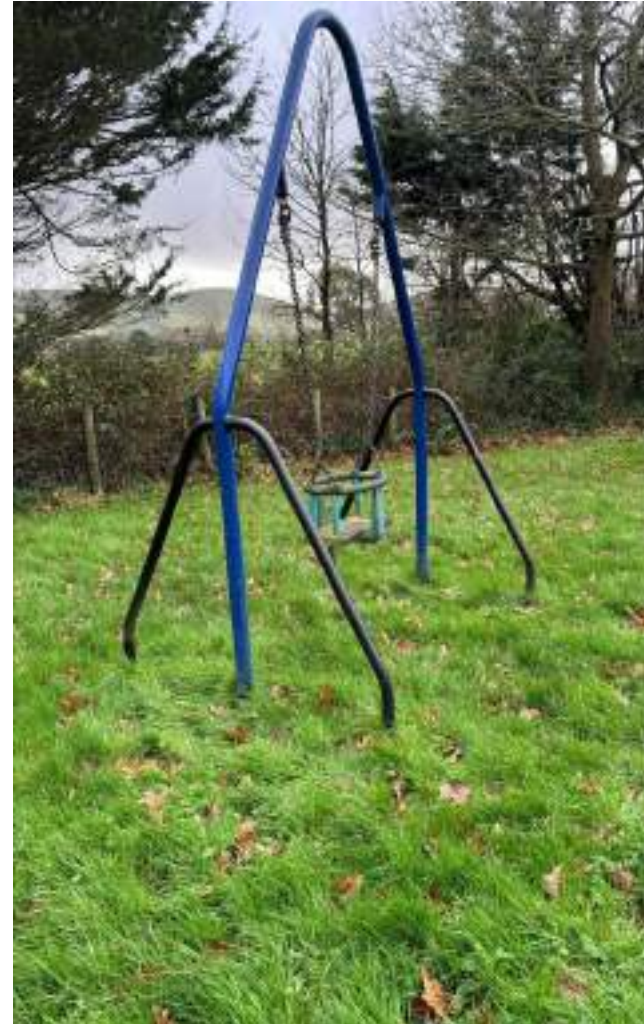
## 4.2 Toddler Swing

This item is in reasonable condition but plans should be made to replace the seat in the next 12 – 18 months.

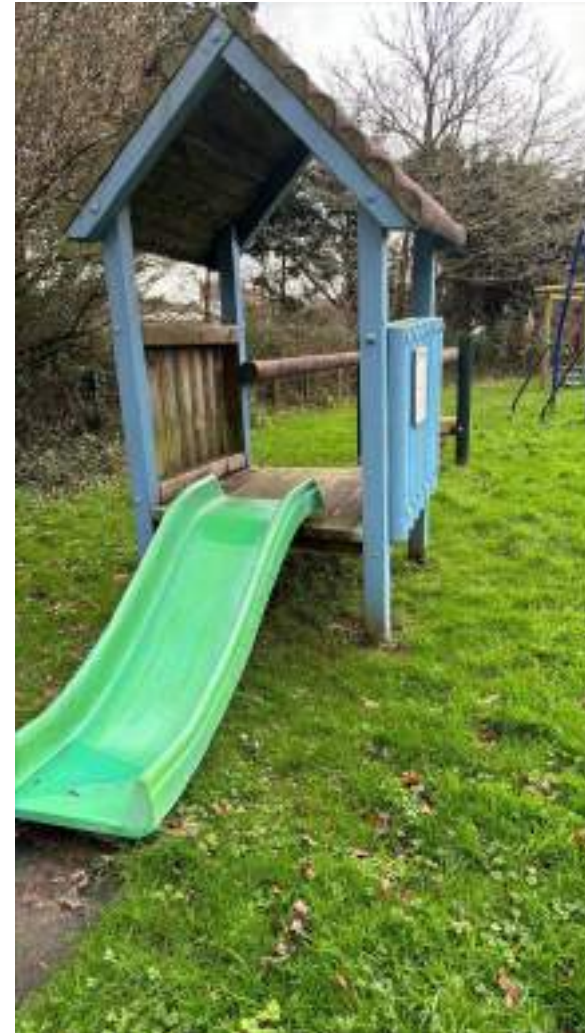
### 4.3 *Playhouse with bridge & Slide*

This item is in reasonable condition for its age.

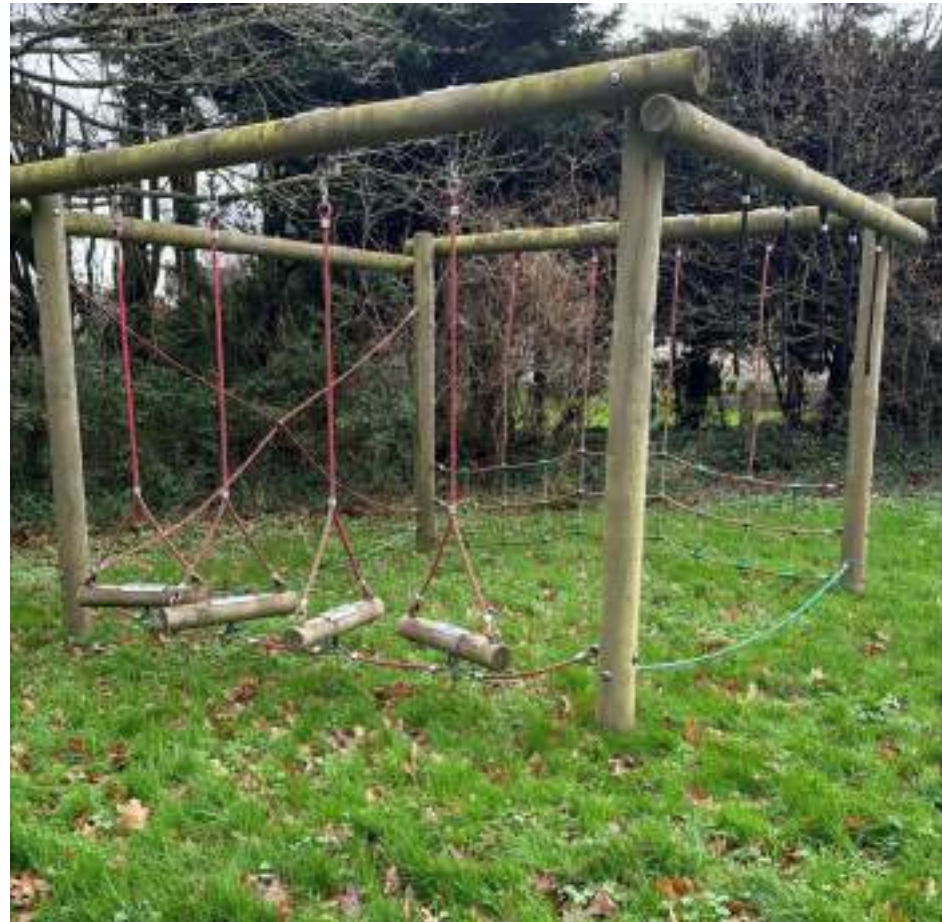
#### 4.4 Sovereign Agility Cube

There are no issues with this unit.

Timber elements should be regularly treated against decay and this item is overdue.

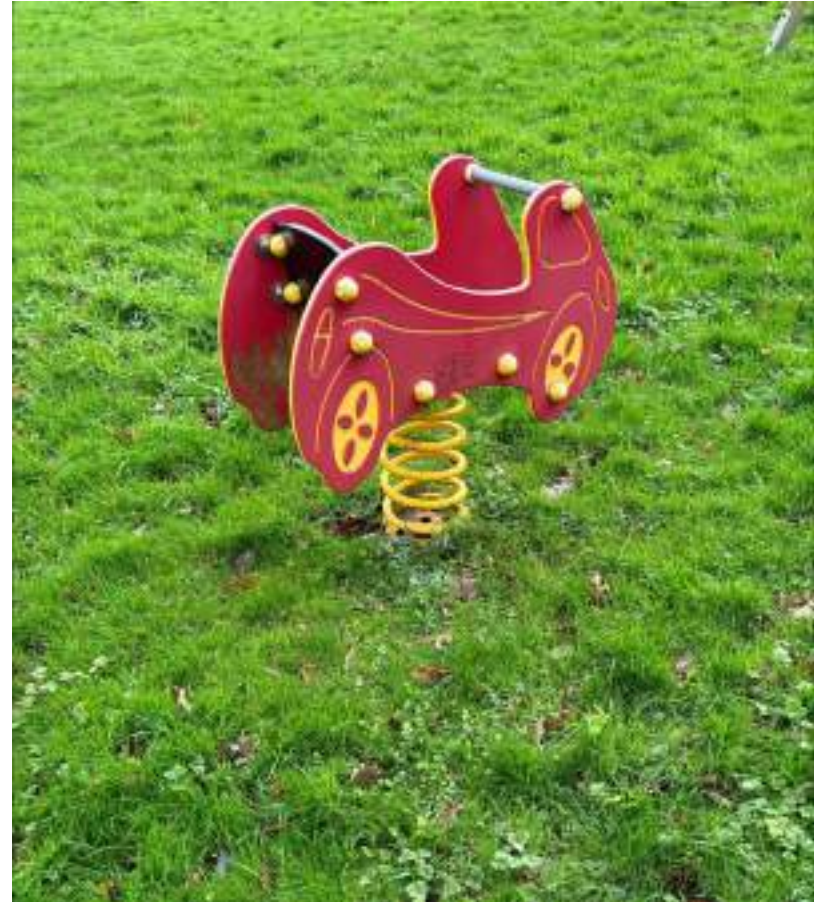
#### 4.5 *Sit in Car Springer*

There is a great of corrosion on the base plates for this unit. Replacement of these components is possible, and costs are shown at 5.

Item	Issues	Recommendation (s)
4.5	The decay in the springer base plate will lead to product failure	Plan for removal and replacement within 2.5 years / possibility of replacement of parts only.
4.8	Timbers are decaying	Replace older timber elements within 2 years. Treat all existing timbers

Item	Issues	Recommendation (s)	Supply Only	Supply & fit
4.5	Springer corroding	Replace parts		POA
4.8	Original timbers decaying	Supply and fit new timbers to Burmese bridge		POA

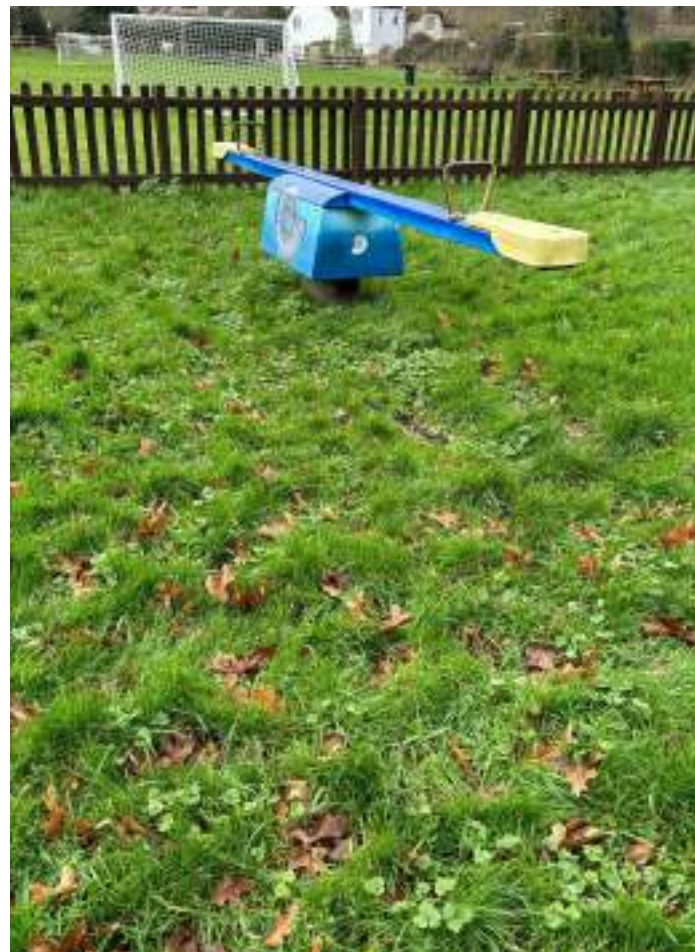
#### 4.6 **Wicksteed See saw**

This item is in reasonable condition.

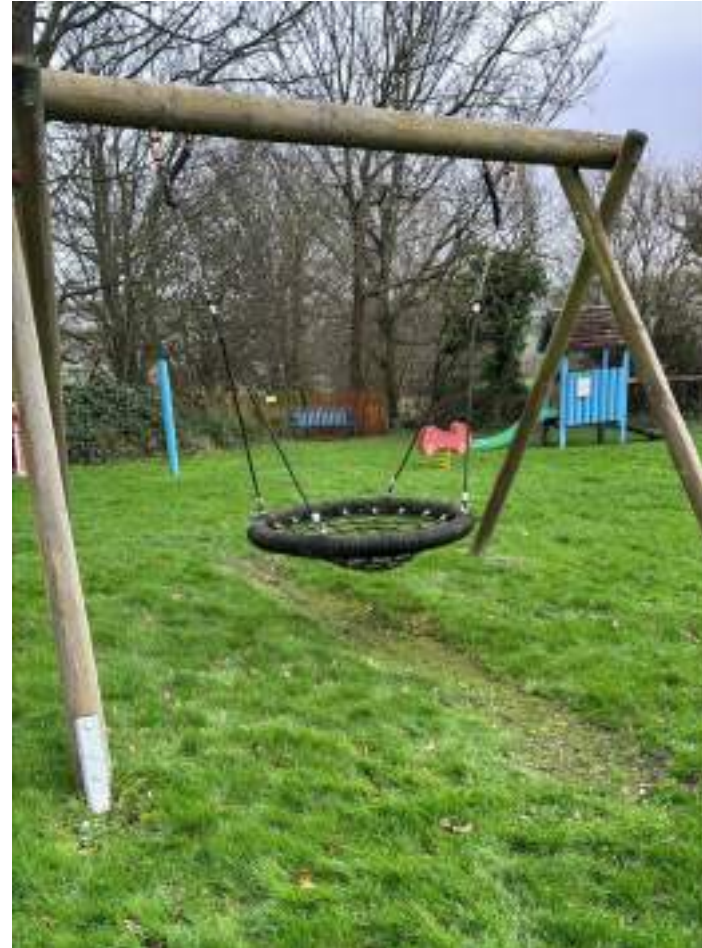
#### 4.7 *Caledonian Play Basket Swing*

This item is in good condition.

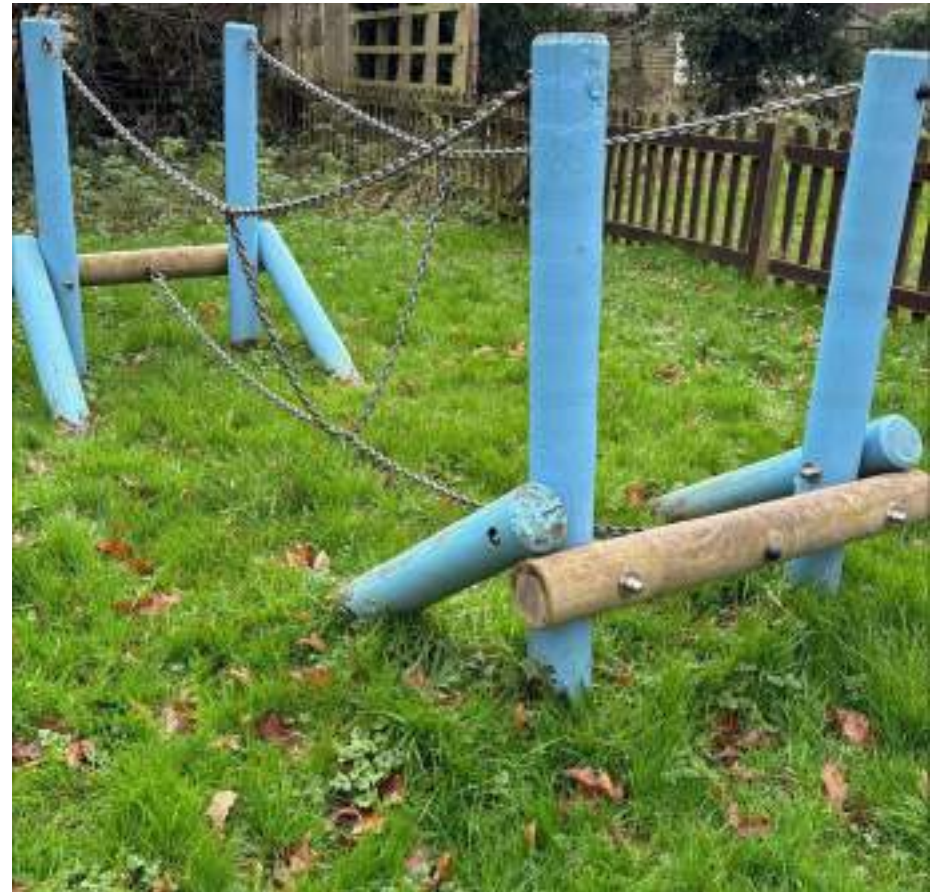
#### 4.8 *Playquest Burmese Bridge*

There are no issues with this item.

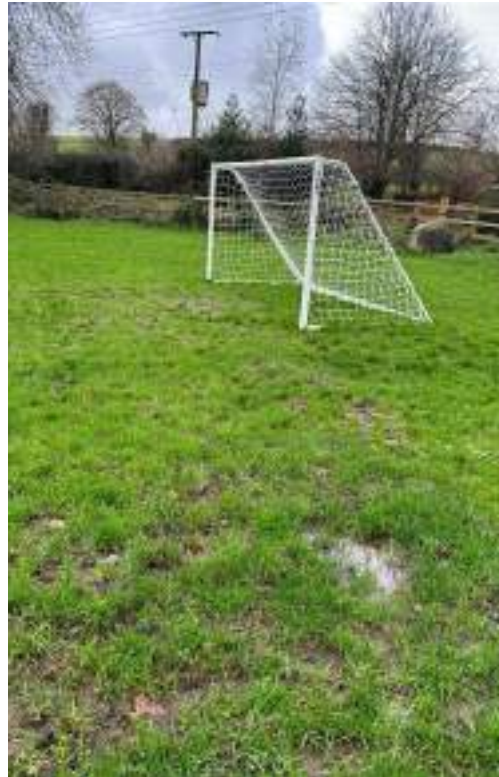
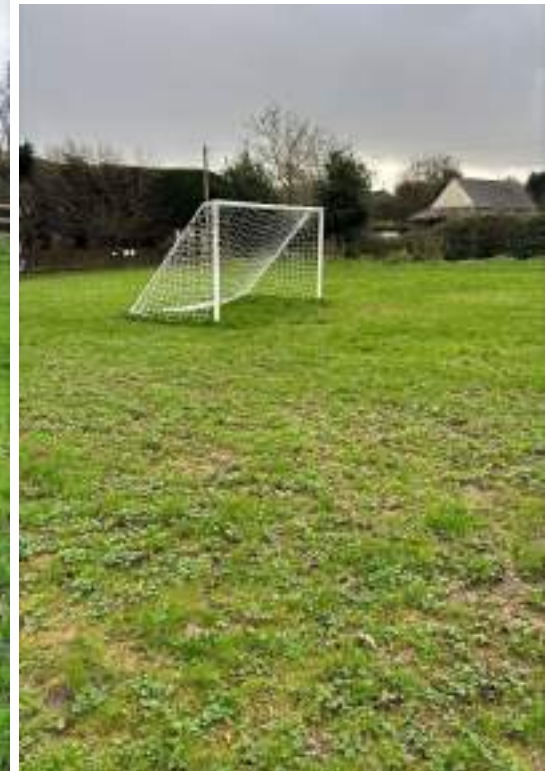
#### 4.9 Goalposts

These newly installed goalposts are in excellent condition.

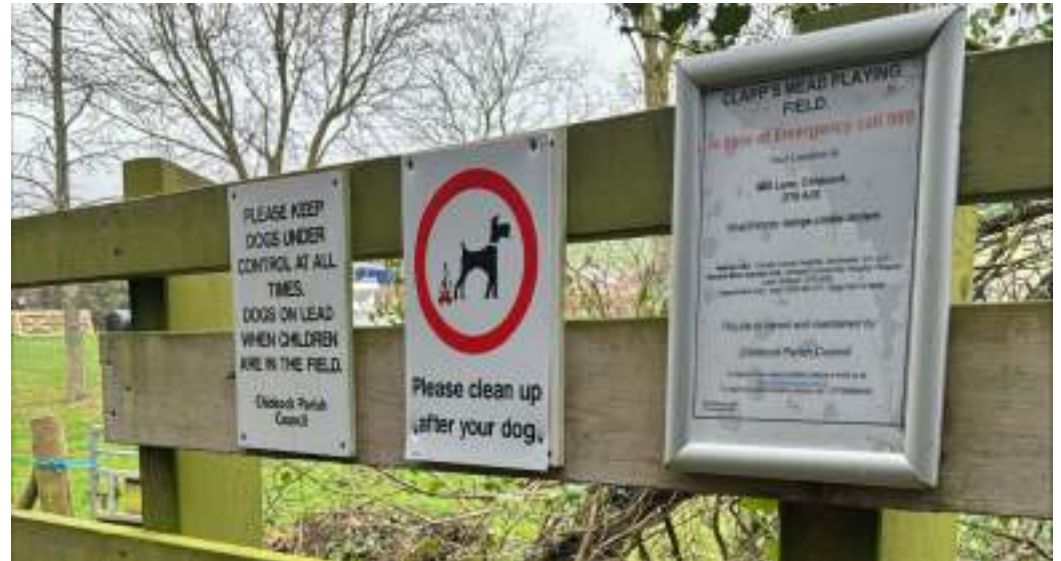
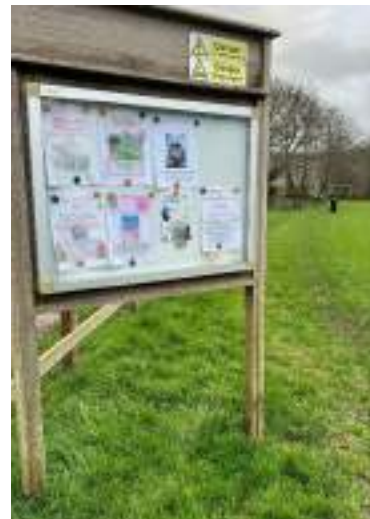
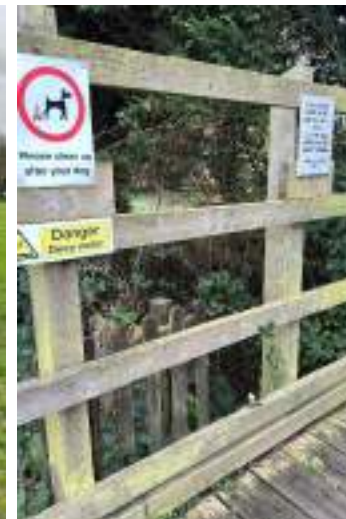
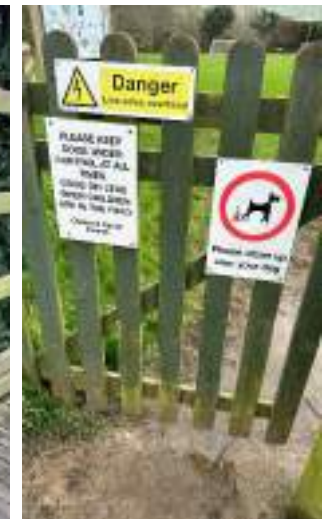
## 4.10 Signs

Suitable signage is in place.

Warnings against deep water and overhead power cables are also present.

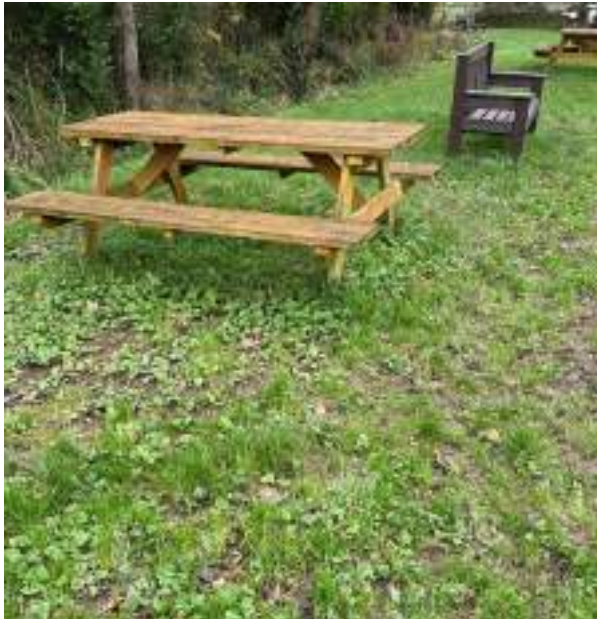
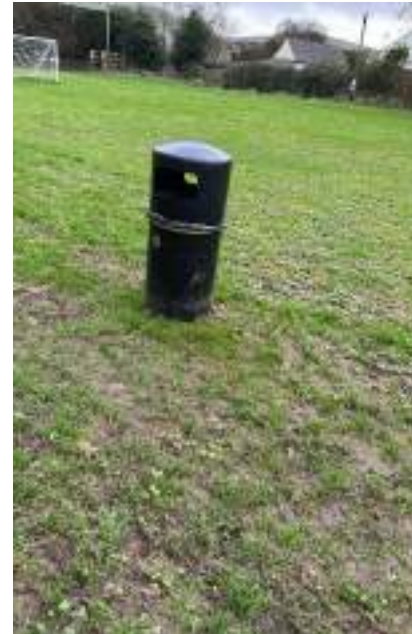
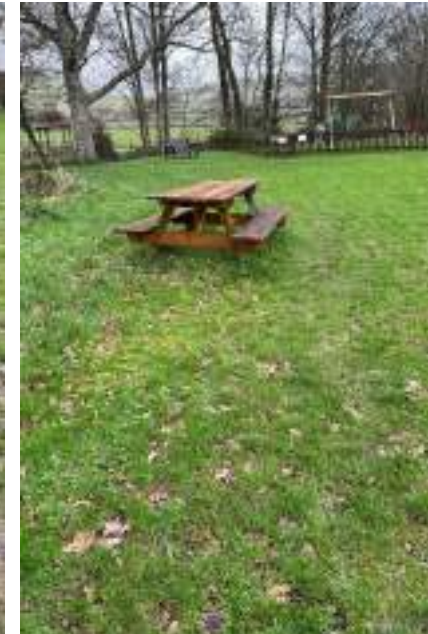
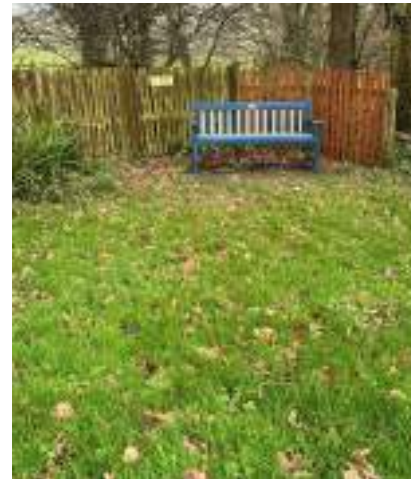
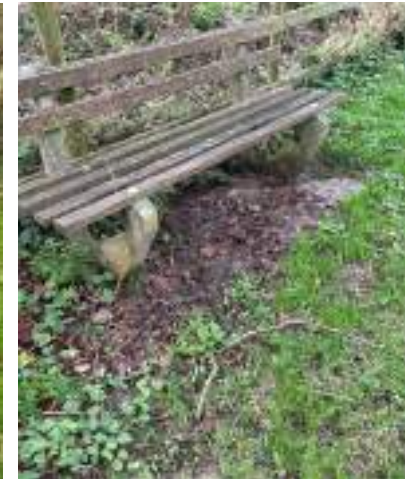
#### 4.11 Barriers, Boundaries, Benches & Bins

The gates are self-closing, and the mechanism is working effectively.

There are several nearby bins and a variety of benches around the site in reasonable condition.
