PLAY AREA SAFETY INSPECTION REPORT

Chideock Parish Council

Inspection undertaken June 2023
This report issued July 5th 2023

Park Name: Mill Lane
Location: Mill Lane, Chideock. DT6 6JS

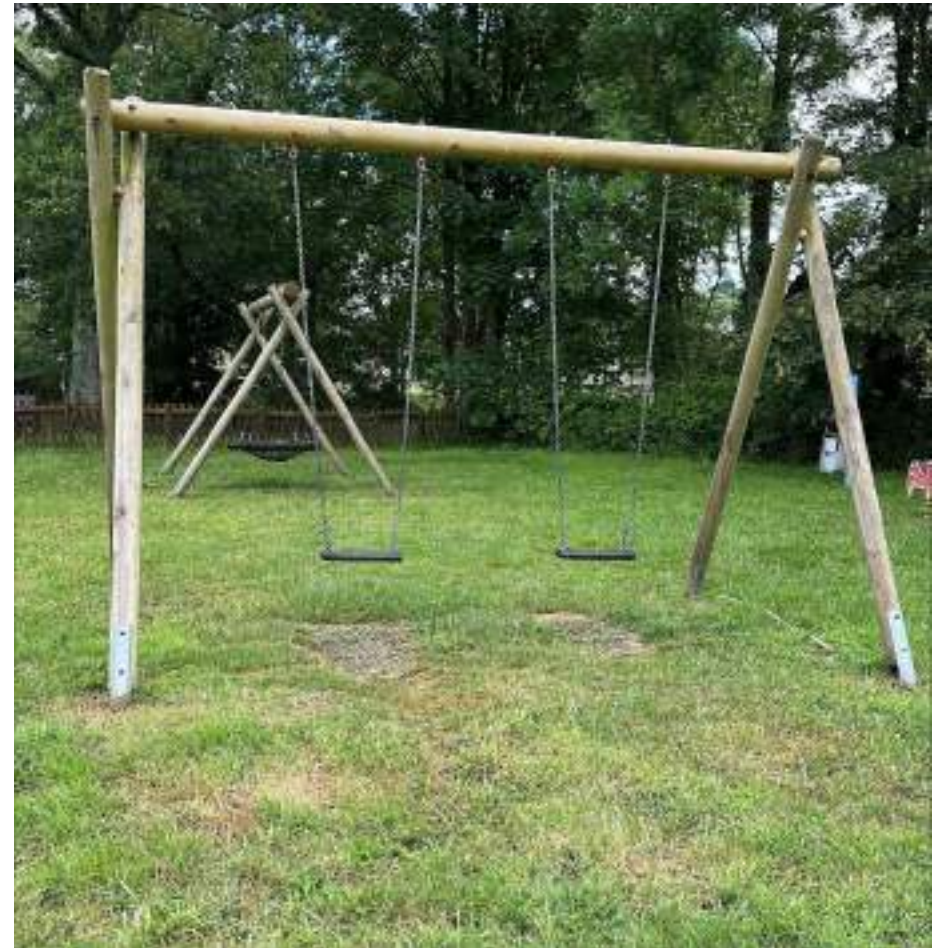
4.1 *Twin Junior Swing Set*

This item is in reasonable condition.

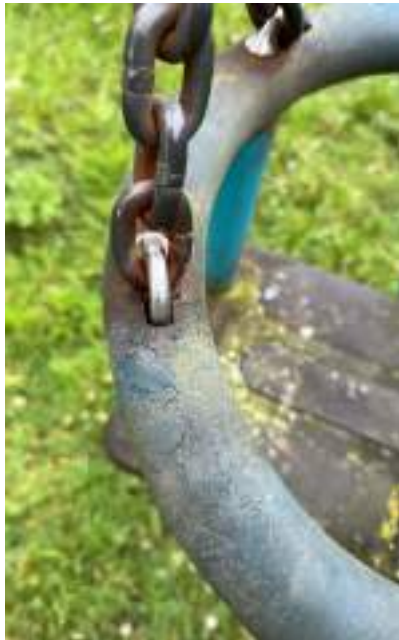
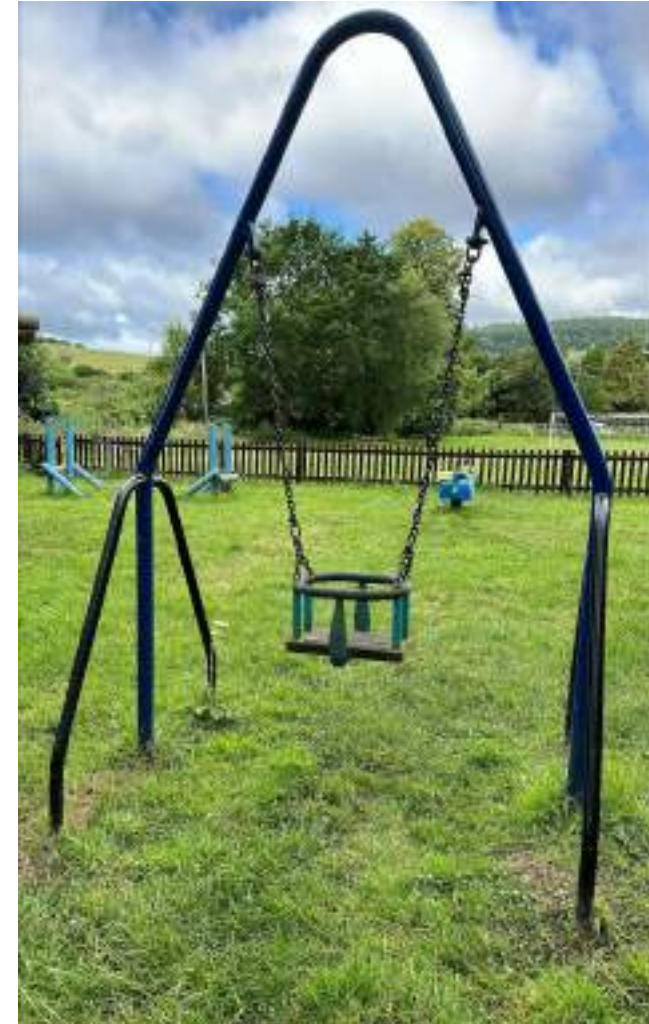
4.2 Toddler Swing

This item is in reasonable condition but plans should be made to replace the seat in the next 12 – 18 months.

The toddler seat is showing signs of corrosion beneath the surface and will be monitored. The swelling and cracking in the rubber is typical of the deformation caused by the expansion in the surface below as rust develops.

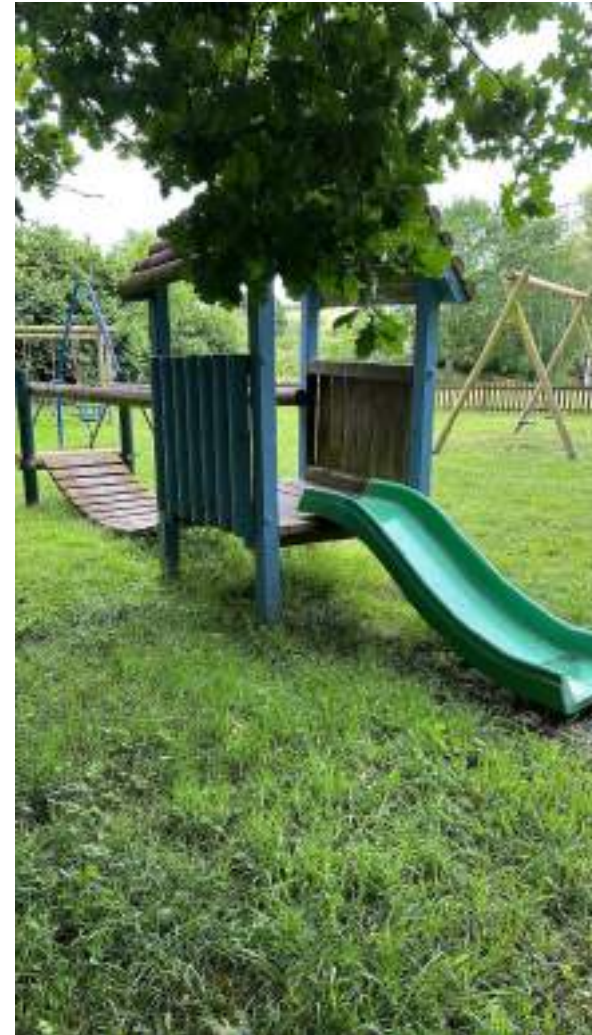
4.3 *Playhouse with bridge & Slide*

This item is in reasonable condition for its age.

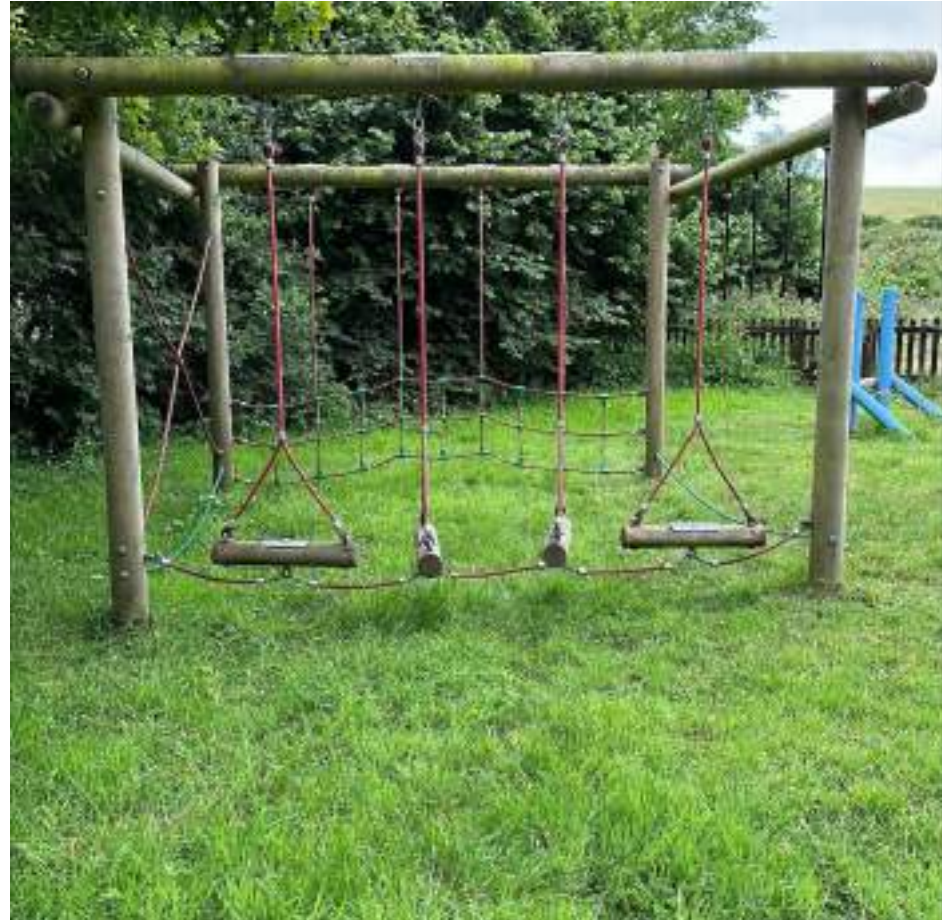
4.4 Sovereign Agility Cube

There are no issues with this unit but timber elements should be regularly treated against decay.

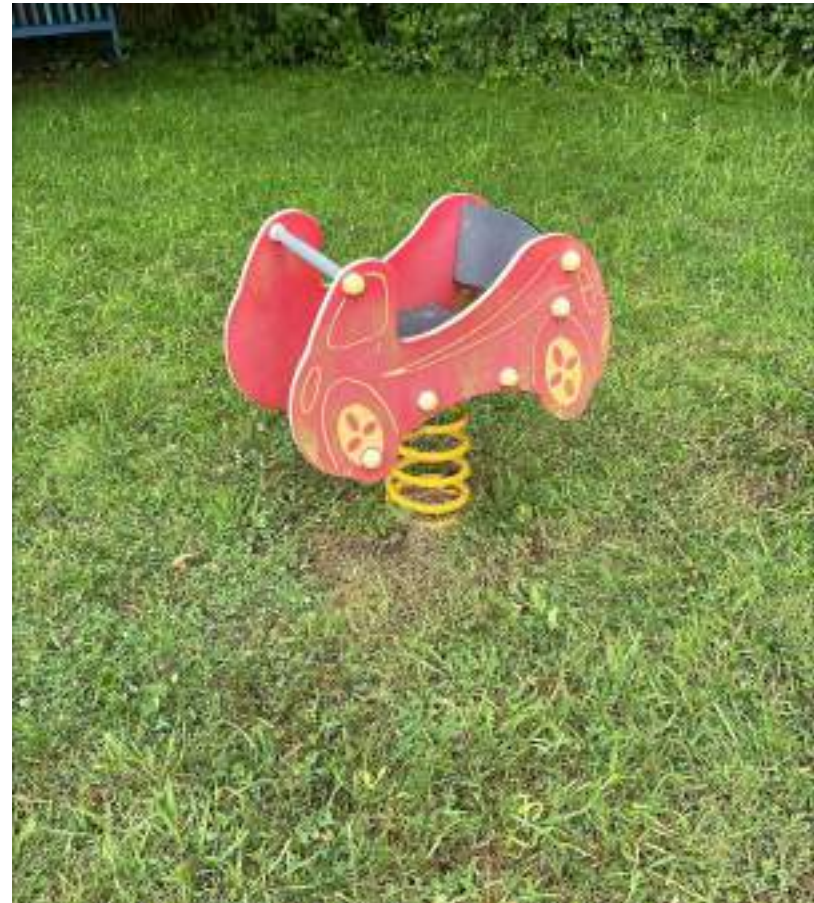
4.5 *Sit in Car Springer*

There is a great of corrosion on the base plates for this unit. Replacement of these components is possible and costs are shown at 5.

Item	Issues	Recommendation (s)
4.5	The decay in the springer base plate will lead to product failure	Plan for removal and replacement within 2.5 years / possibility of replacement of parts only.
4.8	Timbers are decaying	Replace older timber elements within 2 years. Treat all existing timbers
4.11	Blue bench has market decay	Remove/ replace / repair

Item	Issues	Recommendation (s)	Supply Only	Supply & fit
4.5	Springer corroding	Replace parts		£450.00
4.8	Original timbers decaying	Supply and fit new timbers to Burmese bridge		POA

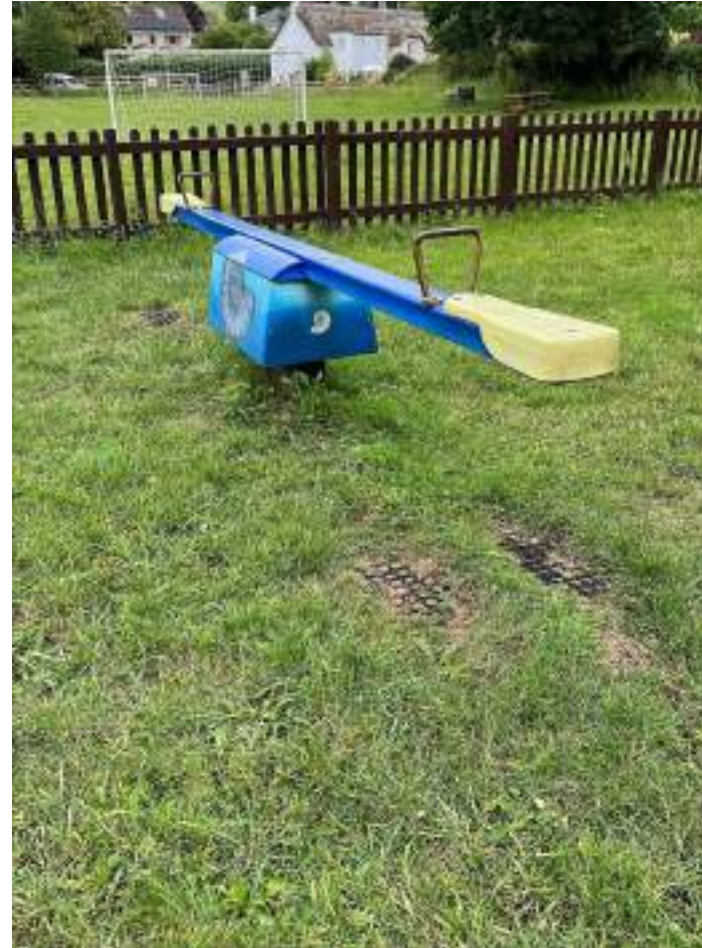
4.6 **Wicksteed See saw**

This Wicksteed see-saw is still in good working order.

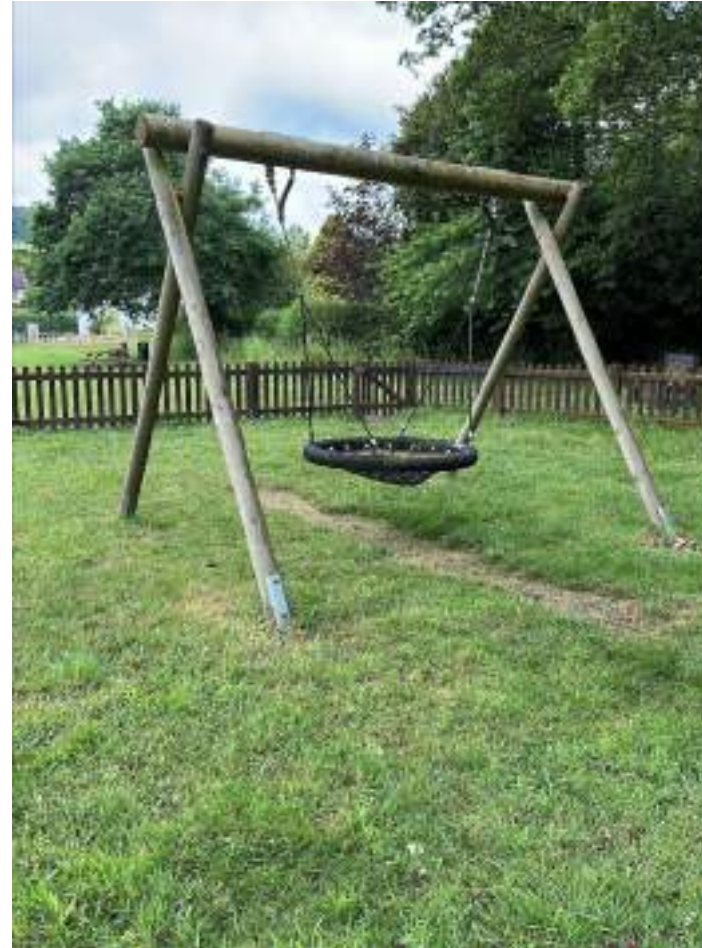
4.7 *Caledonian Play Basket Swing*

This item is in good condition.

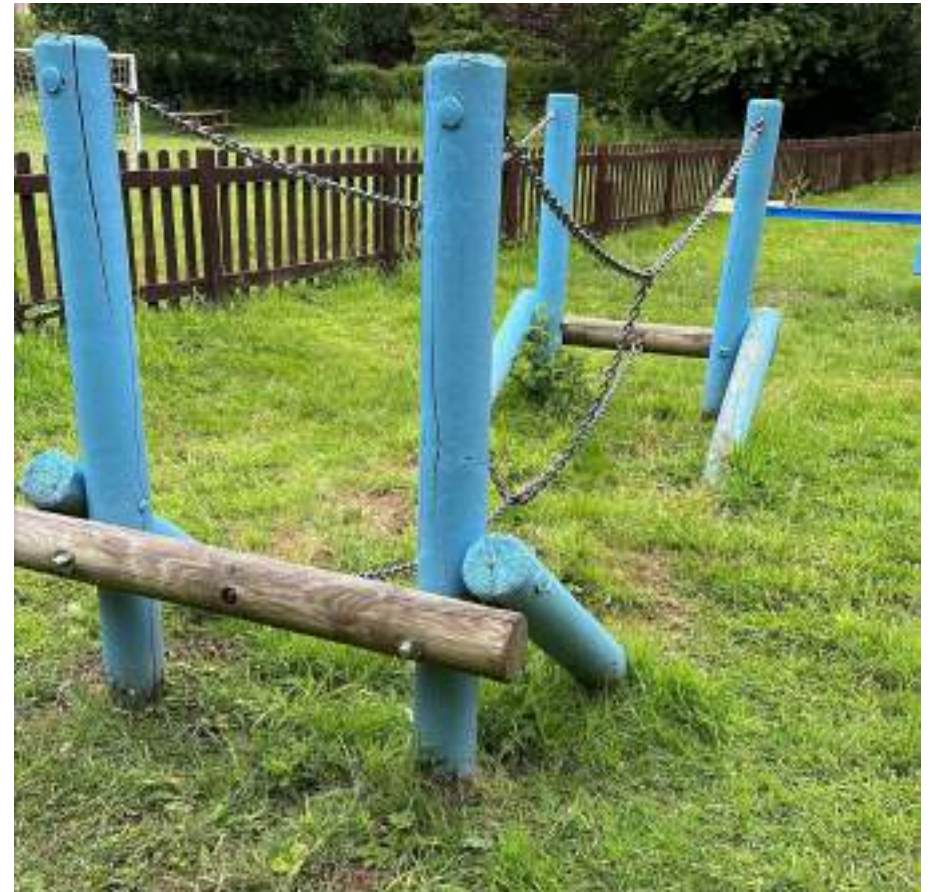
4.8 ***Playquest Burmese Bridge***

This item is in reasonable condition for its age, but the remaining timbers will need replacing soon.

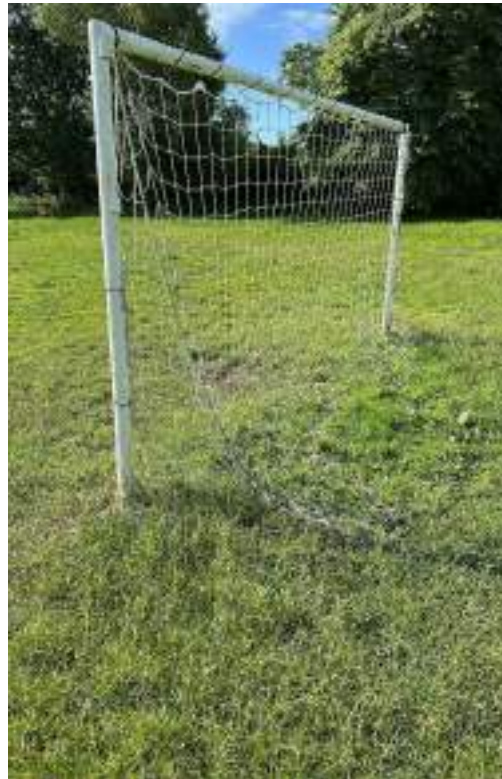
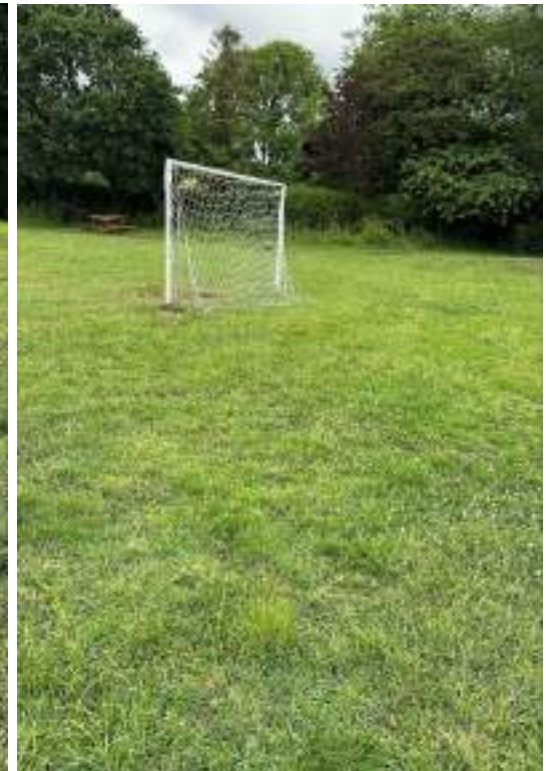
4.9 Goalposts

The goals are due to be replaced with a fixed net style set.

This will resolve the frequent issues with unpegged nets.

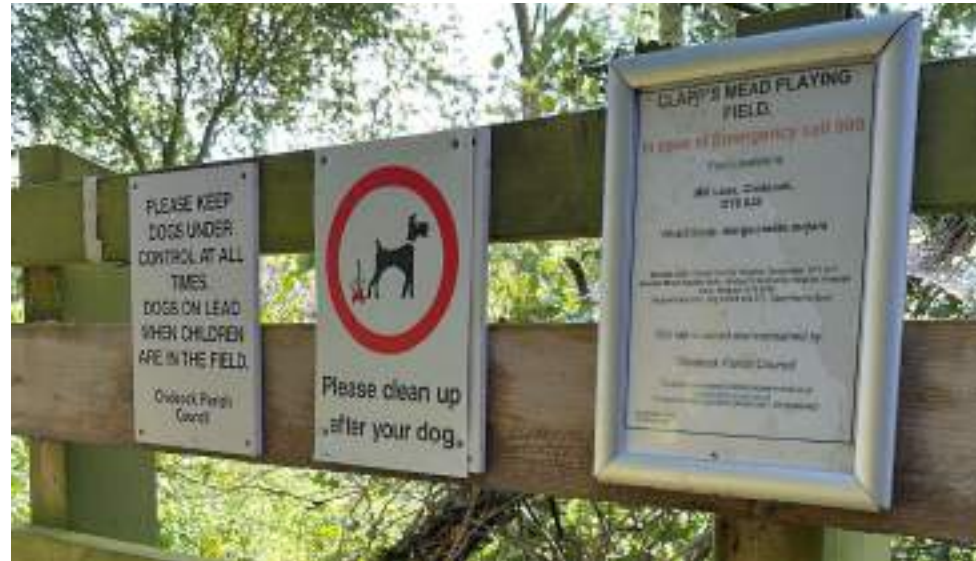
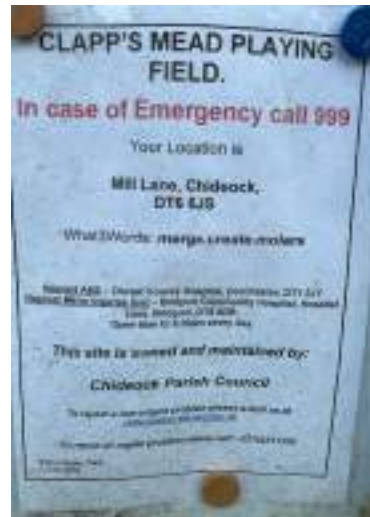
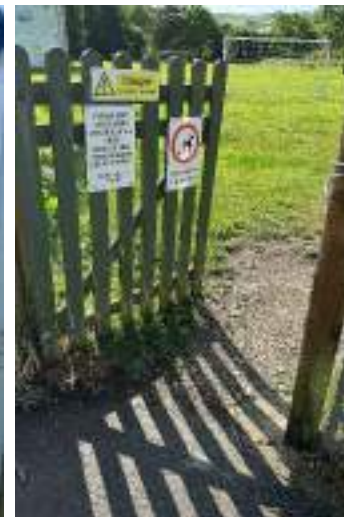
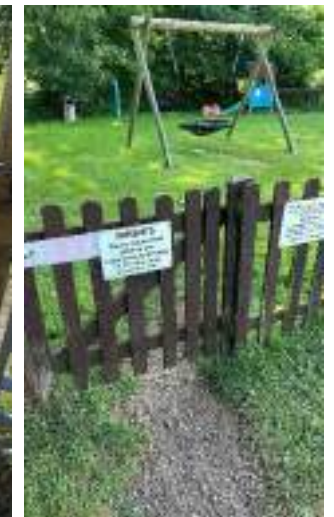
4.10 Signs

Suitable signage is in place.

Warnings against deep water and overhead power cables are also present.

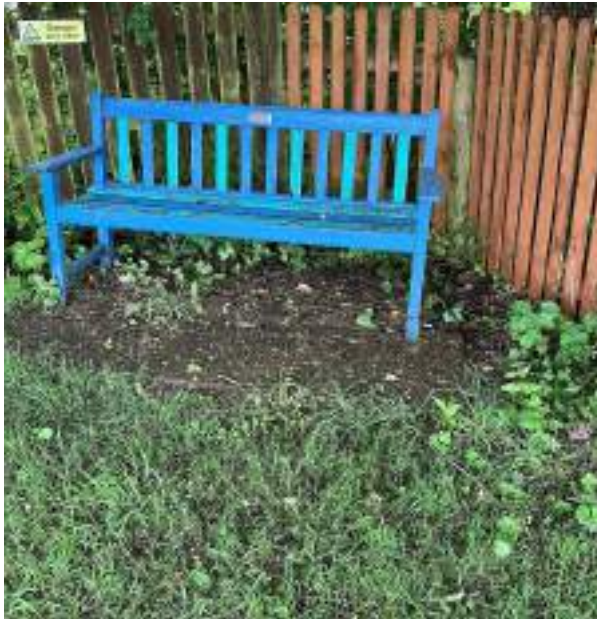
4.11 Barriers, Boundaries, Benches & Bins

There are several nearby bins and a variety of benches. The blue bench below is showing signs of decay and should be removed / replaced / repaired. Others around the site are in reasonable condition.

One bench requires attention and if replaced the new bench should be bought further forward away from the fence line.
