PLAY AREA SAFETY INSPECTION REPORT

Chideock Parish Council

Inspection undertaken June 2023
This report issued July 5th 2023

Park Name: Mill Lane
Location: Mill Lane, Chideock. DT6 6JS

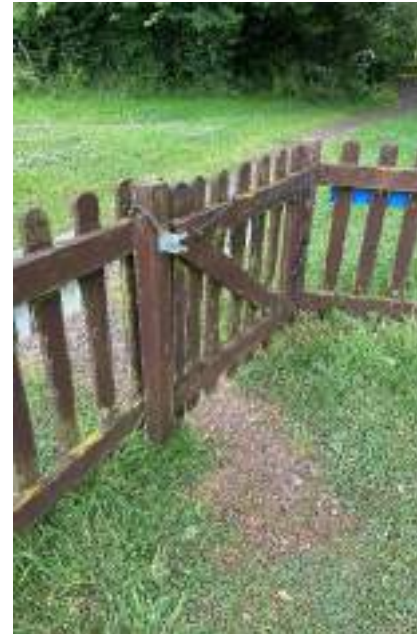
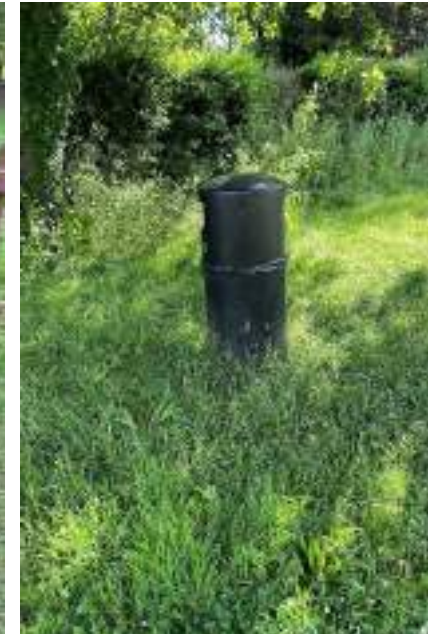
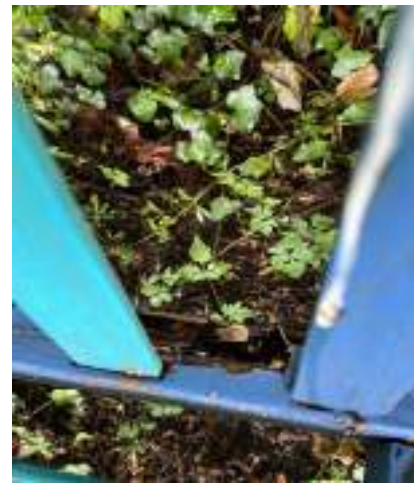
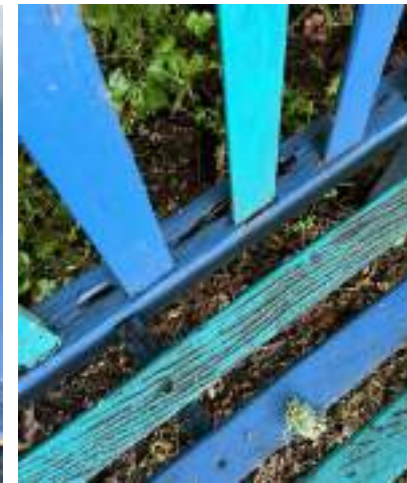
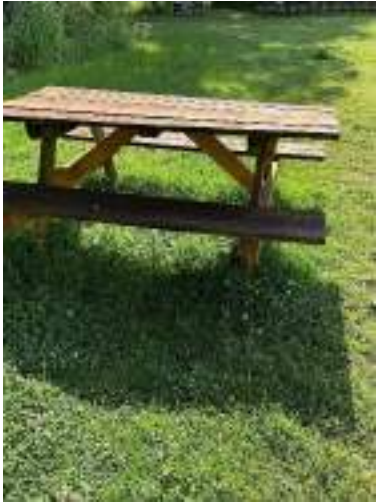
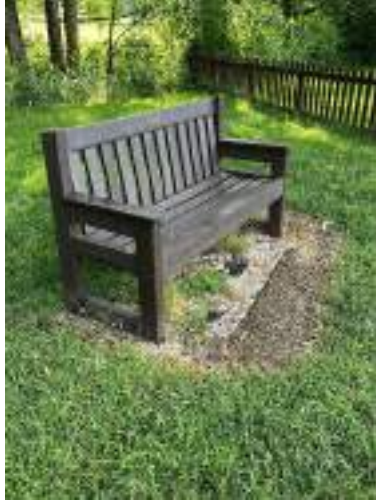
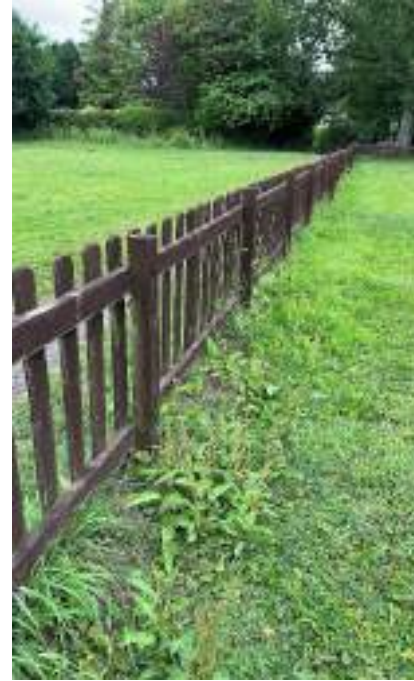
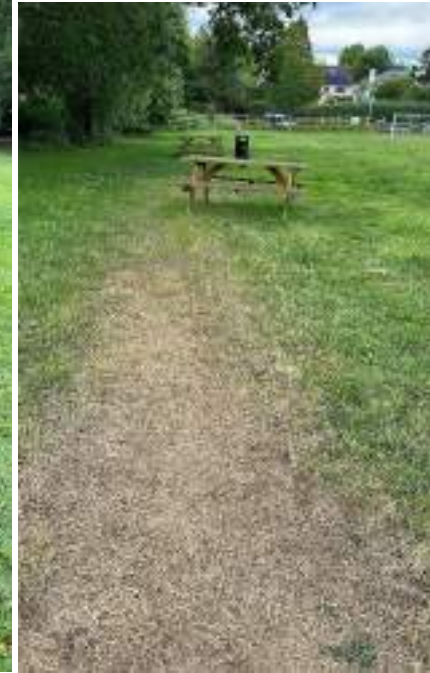
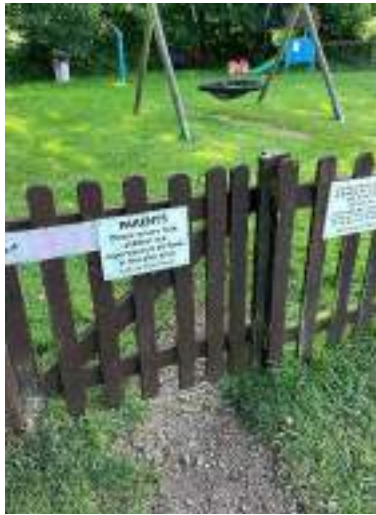
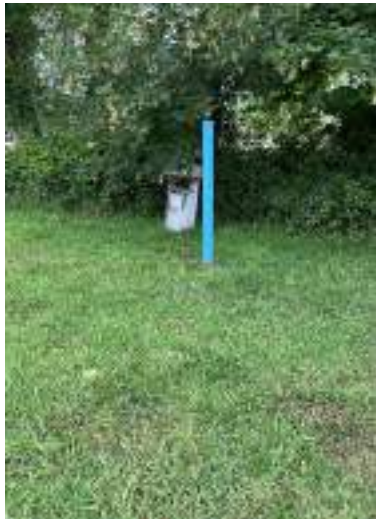
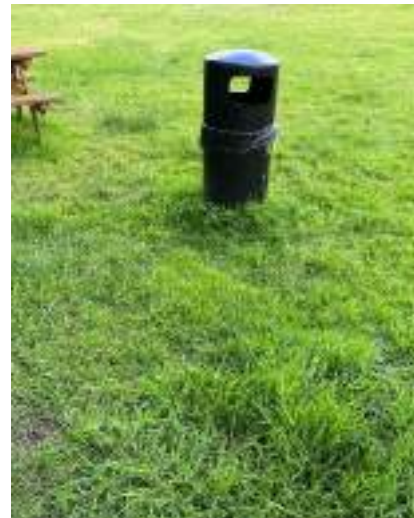
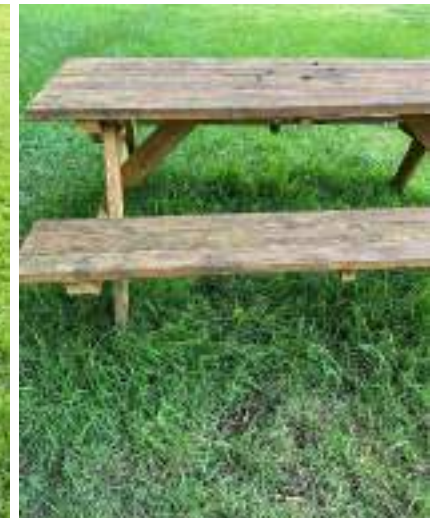
Fencing and gates are in reasonable condition and are being well maintained.

There are several nearby bins and a variety of benches. The blue bench below is showing signs of decay and should be removed / replaced / repaired. Others around the site are in reasonable condition.
