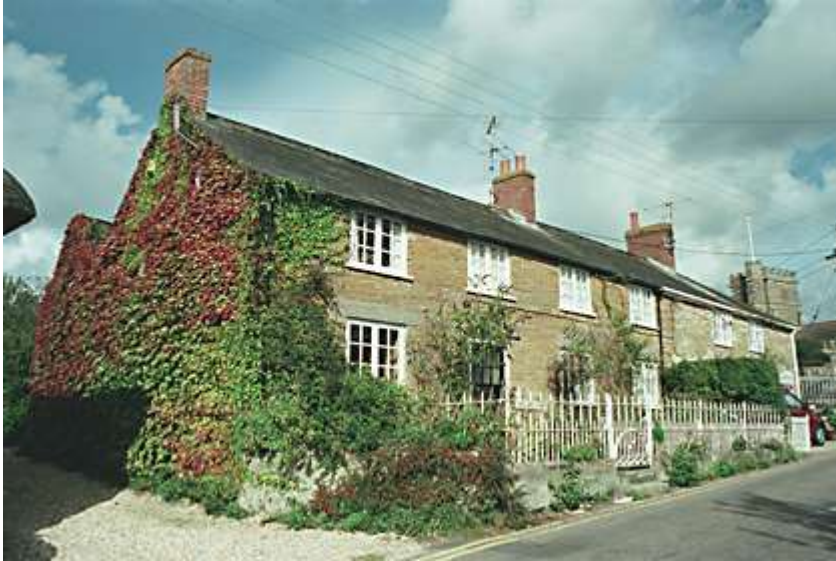
IoE Number: 400406

II Two attached cottages. Early C19. Coursed Lias stone walls. Slate roof with gable end and hipped at right hand. 3 brick stacks, at left hand gable, at ridge centre, at right in from hip apex. 2 storeys. 6 windows, renewed 2 light wood casements with glazing bars. Concrete lintels to left hand, wooden lintels to right hand. Front doors, Midlands: left of centre, C20 plank and glass lights; Chervil: right of centre, wide plank. Front area railings: cast iron C19, points with urns at main divisions

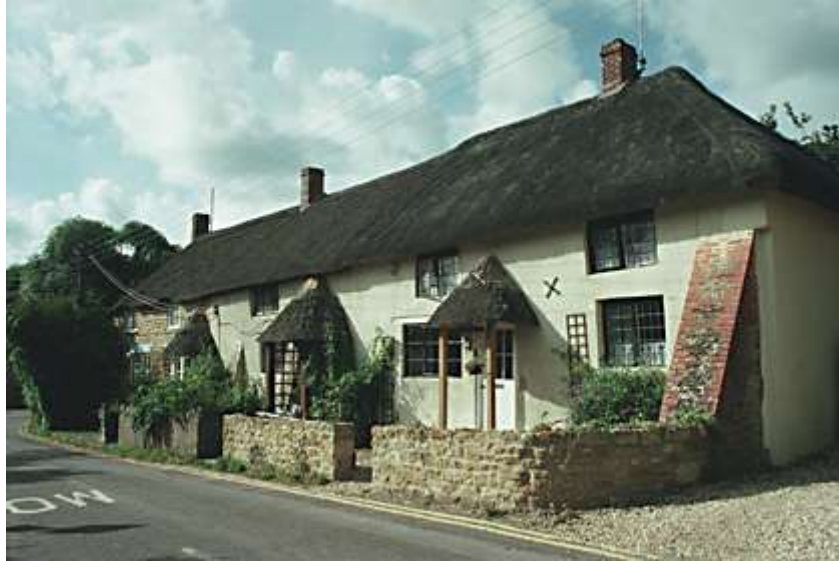
IoE Number: 400416

G.V. II Two attached cottages. c. Early C18. Rubble stone walls, rendered at right hand. Continuous thatch roof, with gable ends. One brick stack at left hand gable. 1 ½ storeys. 5 windows, 2 & 3-light casements with glazing bars, wooden cills and lintels throughout. Front door, at right side of Peter's Finger, wooden C20. Duck Cottage: at centre, plank with brick jambs to doorway. 3 sleeper buttresses to Duck.

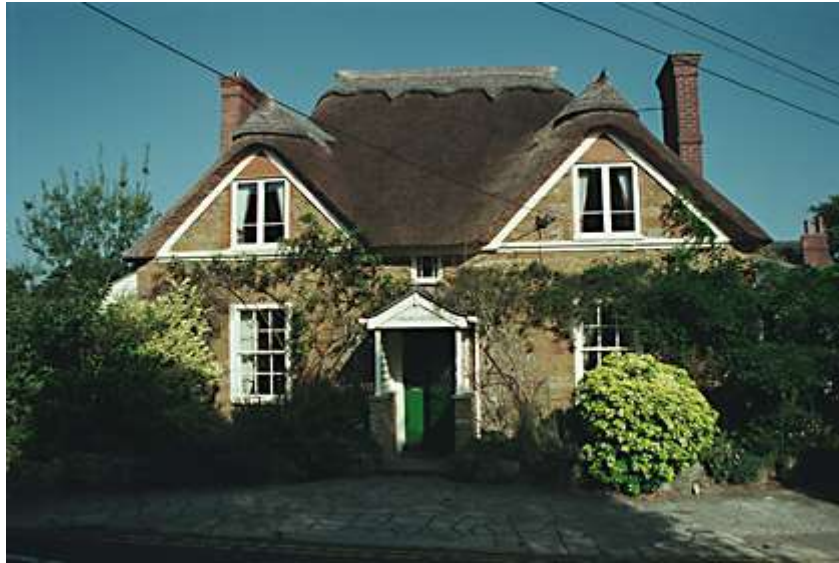
IoE Number: 400422

SY 4292 CHIDEOCK DUCK STREET 9/46 The Swiss Cottage 5.9.60 G.V. II Single cottage in "Picturesque" tradition. Late C18. Lias stone walls. Thatch roof, hipped at both ends. 2 symmetrical front gables with their pitched roofs returning to main roof. Original design brick stacks in groups of 3, at left and right eaves. Moulded caps. 1½ storeys. 3 windows, ground floor with sashes and glazing bars. First floor with 2 light casements in the gables. Very small square window over door. Front door at centre, flush panels with 4 glass lights over. Reeded door surround. Porch, plank sides with trelliswork above. Low-pitched slate roof over, boarded to front. Interior: originally, double- depth plan, with fireplaces in corners, set diagonally. Source: "RCHM Dorset I", p 95 (12).

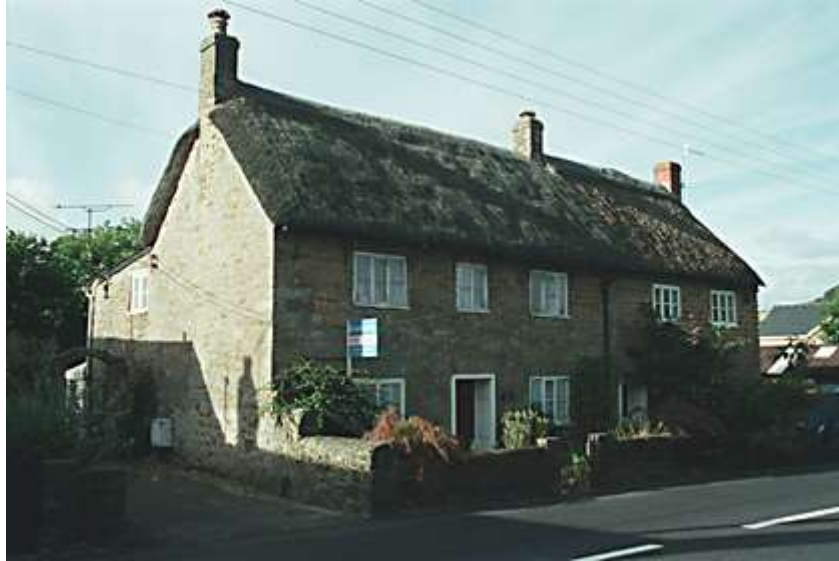
IoE Number: 400809

SY 4292 CHIDEOCK MAIN STREET SOUTH SIDE 9/73 1 and 2 Ashford Cottages, 7.8.52 formerly Ashford Cottage. G.V. II Two attached cottages. Later C18. Coursed lias stone rubble walls. Thatch roof with gable ends. 3 brick stacks: one at left hand gable, one at right hand gable, one at party wall. 2 storeys. 5 windows, wooden casements of 2 and 3 lights. Voussoirs over windows. Front door, at centre of No 1, wood panelled with 2 top lights. Reveals are also panelled. C18. No 2: front door at left, wood C20 with 2 glass panels in top half. Outshut at rear.

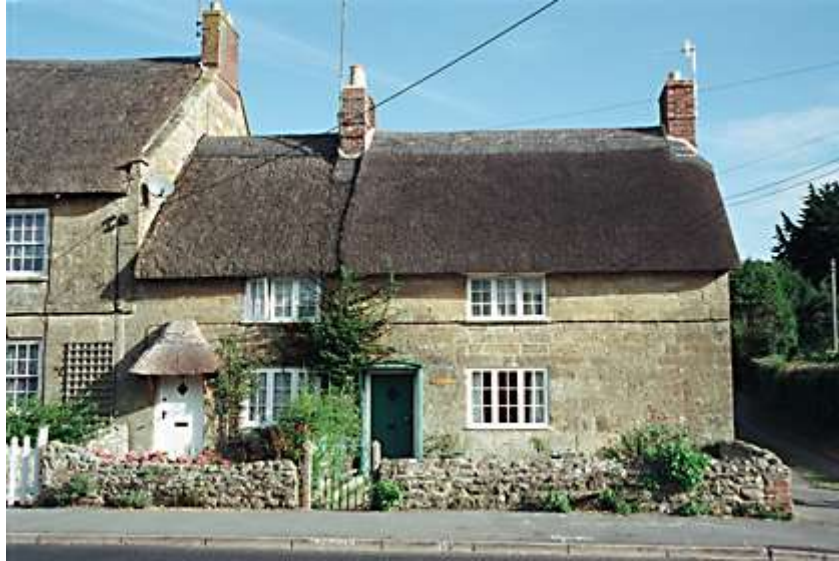
IoE Number: 400710

SY 4292 CHIDEOCK MAIN STREET NORTH SIDE 9/66 1 and 2 Gate Cottages
G.V. II Two attached cottages, continuous with Fernley. c.1810. Ashlar stone walls
coursing carries on from the above. Thatch roof with gable end at right hand. Left
hand end of roof abuts below the gable coping. 2 brick stacks, left of centre, at right
hand gable. 2 storeys. 2 windows, 3 light C20 wooden case-ments with wooden
cills. 2 front doors, at left, of each cottage, both wood C20 with 2 glass panels.
Simple segmental canopies over. Outshut at rear, rubble-stone with Roman tile
pentice over.

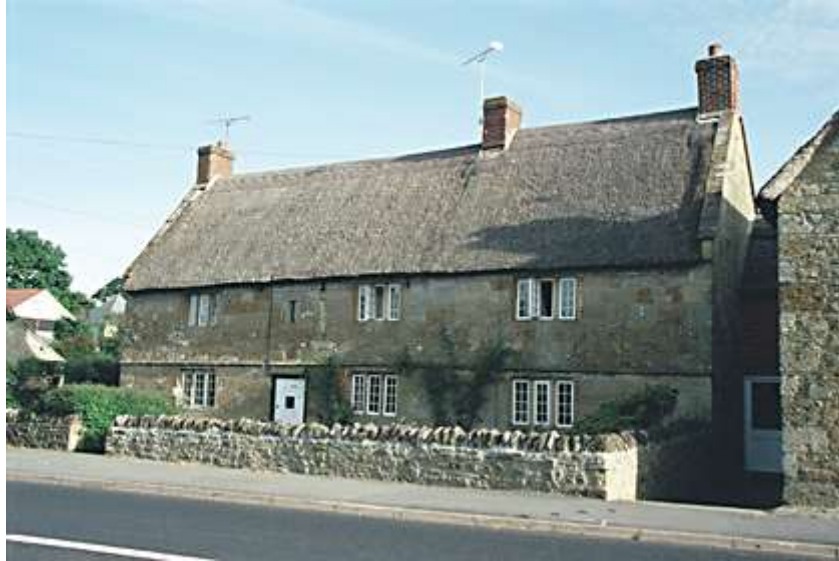
IoE Number: 400711

SY 4292 CHIDEOCK MAIN STREET NORTH SIDE 9/67 1 and 2 Park Farm 7.8.52 Cottages G.V. II Two cottages in a former farmhouse. Early C17. Dressed lias stone walls, coursed and squared. Thatch roof with gable ends and stone gable copings. 3 brick stacks: at left hand gable, at right of central room, at right hand gable. 2 storeys. 4 windows, 3 light hollow-chamfered mullions throughout. Left and right lights are fixed with iron stanchions and leads. Centre lights are casements with wooden or metal frames. Small rectangular stair-light over front door. 2 small attic windows in west gable wall with separate labels over. C17. Dripstone string course runs continuously over ground floor windows. RCHM, Dorset I", p 95 (8).

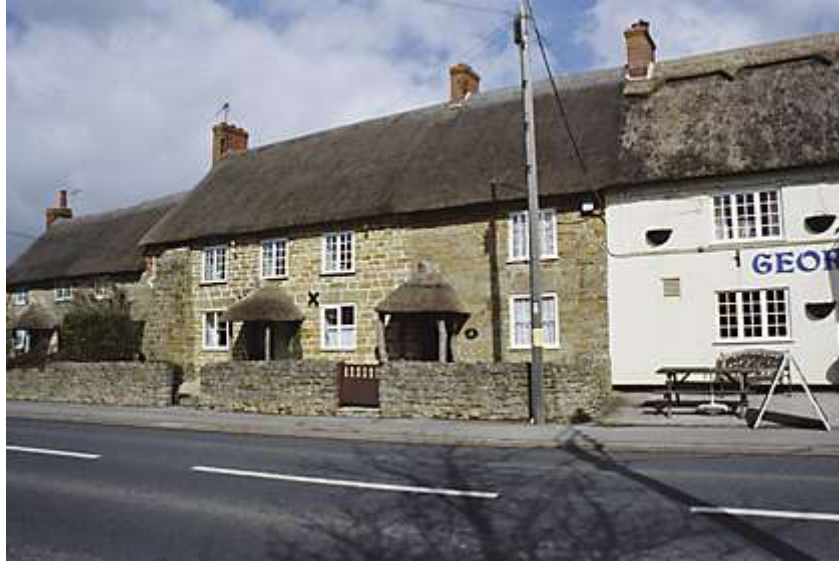
IoE Number: 400651

SY 4292 CHIDEOCK MAIN STREET NORTH SIDE 9/62 1 and 2 Sunnyside 5.9.60
G.V. II Two attached cottages. C18. Coursed Lias stone walls, with large sleeper buttress at left hand end of eaves (recent). Thatch roof with gable end at left hand and continuous with roof of The George at right hand. Two C20 brick stacks, at left hand gable, and at party wall. 2 storeys. 4 windows, 2 light wooden casements with glazing bars and old glass. 2 front doors, at centre of No 2, plank with hipped thatch canopy over, carried on wooden posts. No 1 has a C19 wooden door with glass panels over, with similar thatch canopy over. Interior: No 2 has an open fireplace with wooden lintel and C19 brick jambs to it.

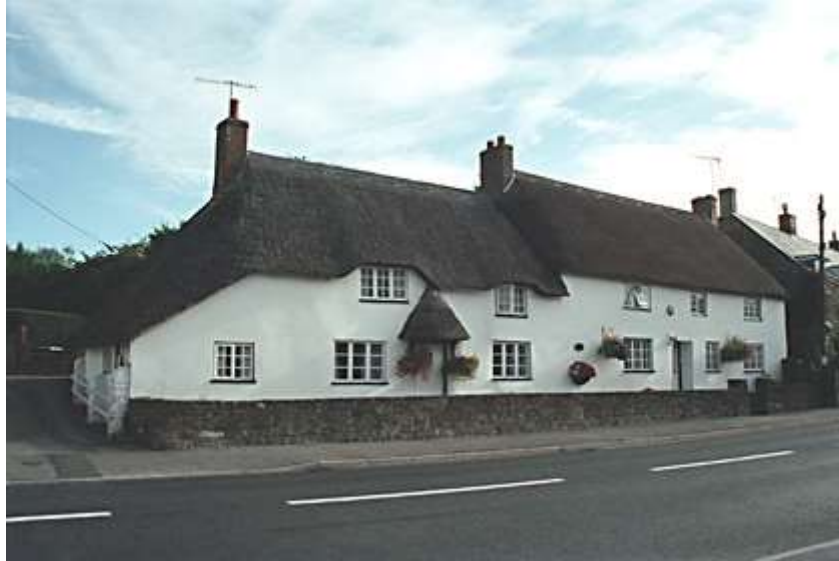
IoE Number: 400584

SY 4292 CHIDEOCK MAIN STREET NORTH SIDE 9/55 Apple Tree Cottage 7.8.52 and Apple Tree Thatch G.V. II Attached cottage and house, C18. Apple Tree Cottage: stone walls, rendered and washed. Thatch roof with big catslide hip at left hand. One C20 brick stack at left end of ridge. 1 ½ storeys. 3 windows, 2 and 3-light wooden casements with glazing bars and wooden lintels over. Front door at centre, wood C20 with beading. Thatch canopy carried on wooden brackets over. Apple Tree Thatch, of same materials with brick quoins at right hand. Two C20 brick stacks at left and right gables. 2 storeys. 3 windows, mainly 3-light wooden casements with glazing bars. Fixed leaded lights, topleft. Front door, left of centre, C20 plank with 6 glass panels over.

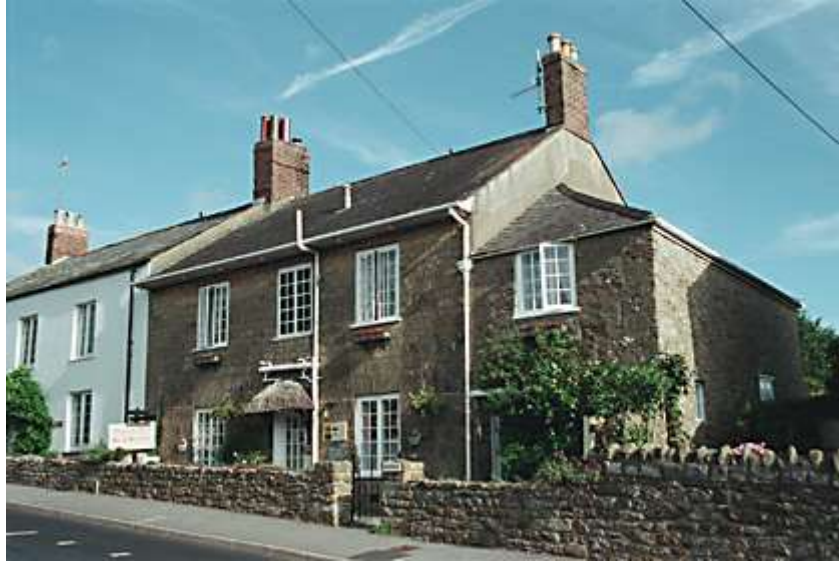
IoE Number: 400500

SY 4292 CHIDEOCK MAIN STREET NORTH SIDE 9/47 Betchworth House 5.9.60
G.V. II Attached house. Early C19. Lias stone ashlar walls. Slate roof with gable ends and boxed-in eaves. C19 brick stacks at left and right hand gables. 2 storeys. 3 windows, 2-light wooden casements with glazing bars. Stone voussoirs to windows. Centre upper window, blocked. Front door, at centre, C20, wood and glass-paned throughout. C19 lias stone extension to right. Two storeys, one bay under a hipped slate roof. Same window-type as above.

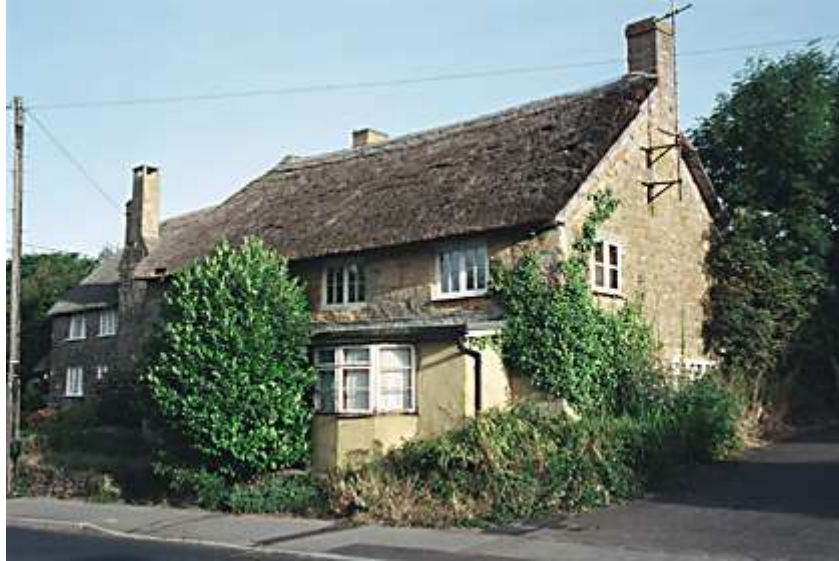
IoE Number: 400600

SY 4292 CHIDEOCK MAIN STREET NORTH SIDE 9/60 Box Cottage 7.8.52 G.V. II
Single cottage. Later C18. Lias stone walls, coursed and patched. Thatch roof, half-hipped at left hand, gabled at right hand. One C20 brick stack at right hand gable. 2 storeys. 3 windows, 2 light wooden casements with glazing bars. Small canted bay-window to left, ground, fills a former shop entrance. C20 bay at right, ground, is not listed. Central outshut at rear Rubble stone with pentice Roman tile roof over.

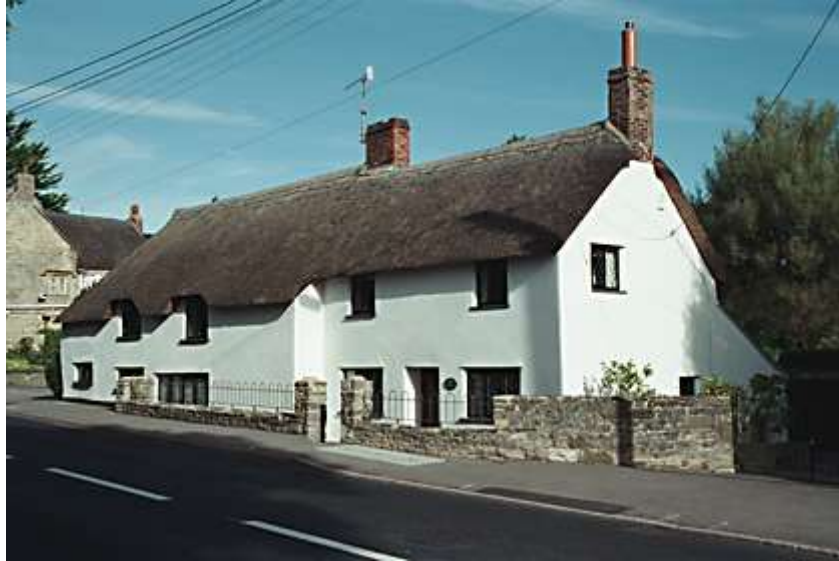
IoE Number: 400582

II Single cottage, formerly two attached cottages, c.C18 with C20 alterations. Rubble-stone walls, washed, with wall set back at right hand end. Thatch roof with gable ends and higher eaves-line at right hand end. 2 brick stacks, at ridge (party wall), at right hand gable. 1 ½ and 2 storeys. 4-5 windows, left end has C20 metal casements of 2 and 4 lights with wooden cills. Right end has C20 wooden casements with lozenge leaded lights. Front door of plank at centre of right hand part. Rubble-stone outshuts at rear with concrete Roman tile roof.

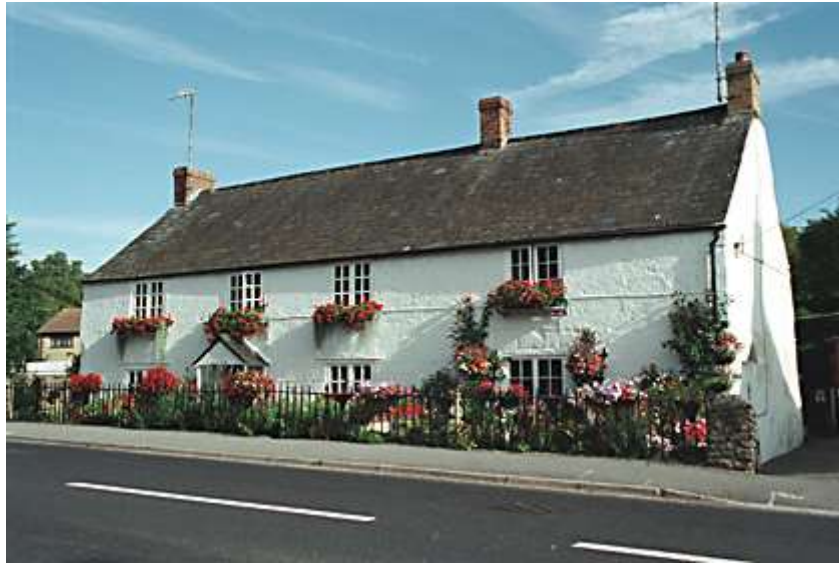
IoE Number: 400583

SY 4292 CHIDEOCK MAIN STREET NORTH SIDE 9/54 By The Stream and 7.8.52
St addlestones G.V. II Two attached cottages, early C19. Lias stone walls, washed.
Slate roofs with gable ends and tile ridge. 3 brick stacks, at left hand gable, party
wall and right hand gable. 2 storeys, whole range is 4 windows. 2 light wooden case-
ments with glazing bars and wooden cills. Some old glass. Front door at centre, left,
wood with flush panels and 6 glass lights. Continuous C19 outshut at rear of both,
washed rubble walls and Roman tile pentice roof. Iron railings to front area with fire-
tongue finials and urns.

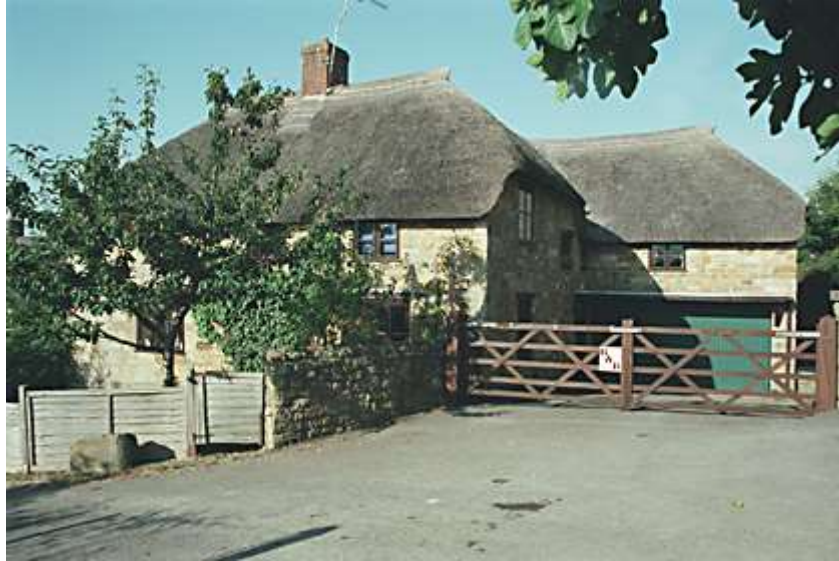
IoE Number: 400713

SY 4292 CHIDEOCK MAIN STREET NORTH SIDE 9/69 Cart Shed, Park Farm, 15 metres north east of The Cheese House G.V. II Cart Shed with loft over. C17. Coursed lias stone walls. Hipped thatch roof over. Rectangular plan. 1½ storeys. Entrance to cart shed in north gable wall: lower part, open; upper part is weatherboarded. Door in south gable wall, plank with large hinges and wooden lintel over. Interior: large wooden ceiling beams, stopped, support the renewed joists of the loft. Collar-beam roof construction.

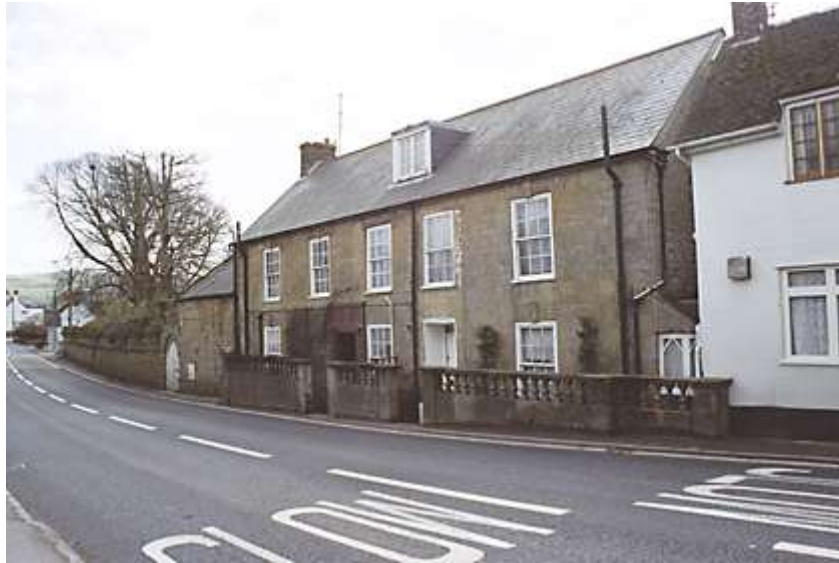
IoE Number: 400814

SY 4292 CHIDEOCK MAIN STREET SOUTH SIDE 9/74 Chideock Court and 7.8.52 attached stone wall along Main Street, formerly Bridge Court. G.V. II Single house. C17, C18 and C20 rear extensions. Coursed lias ashlar walls. Slate roof with gable ends. Brick stack at left hand gable. 2 storeys. 5 windows, sashes with projecting keys and voussoirs. Dormer in roof with wooden casements. Door on to main road, wooden, C20 with glass panels. Reeded pilaster surround. Large extensions of c 1920, in an early Tudor style at "rear", being the present front, of the house. Interior: heavy mid- chamfered beams, c C17. The house has been greatly altered inside and its plan is not recoverable. Attached stone wall for 40 metres, along road to the bridge. Pointed door at the centre, with brick arch over. "RCHM, Dorset I", p 95 (9).

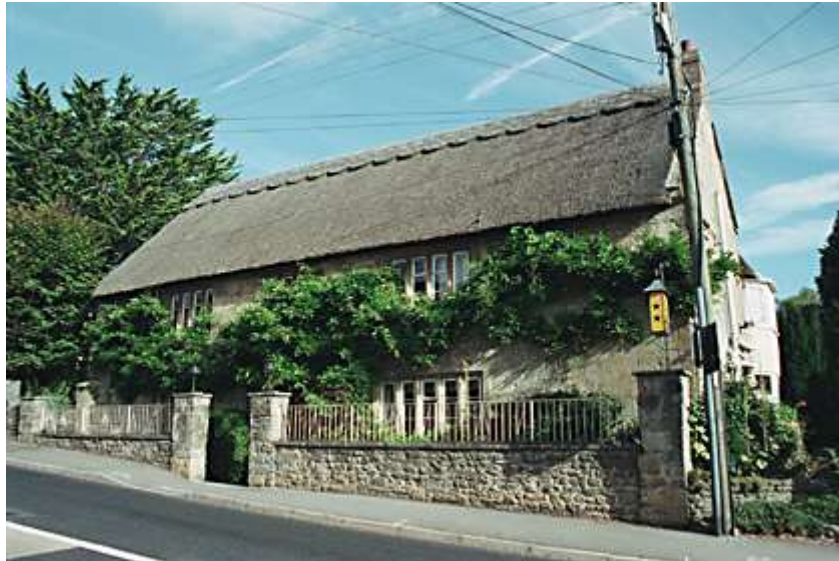
IoE Number: 400579

SY 4292 CHIDEOCK MAIN STREET NORTH SIDE 9/52 Chideock House Hotel
5.9.60 (formerly listed as G.V. chideock House) II Single house, now hotel, with rear
attachments, early C17. Coursed Lias ashlar walls. Thatch roof with gable ends and
stone gable copings. One brick stack at right hand gable. 2 storeys. 3 windows,
stone mullions with hollow chamfers, of 3, 4 and 5 lights. C20 metal casements
therein. Stone mullions in west gable, part blocked. Front doorway, left of centre,
stone surround", with slight hollow chamfer. C20 door, wood with many glass panels.
Thatched rear wing at east gable end with canted bay. Interior: early C17 mid-
chamfered beam with small fillets. Fireplace in right hand room: massive lintel with
straight chamfer. "RCHM, Dorset I", p 95 (4).

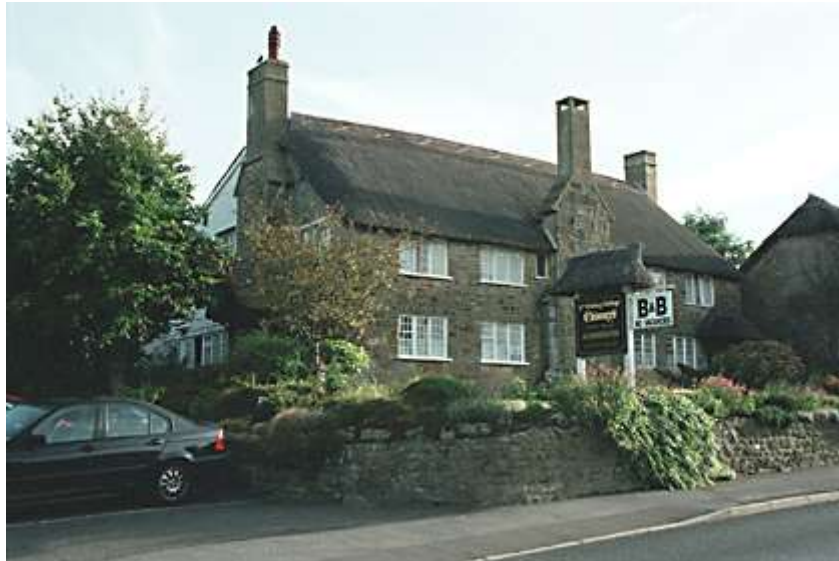
IoE Number: 400599

SY 4292 CHIDEOCK MAIN STREET NORTH SIDE 9/59 Chimneys Hotel, 7.8.52 formerly Old Chimney Cottage G.V. II Hotel, formerly large gentry house. C16, with modern rebuilding at the rear (roof pitch raised) and refenestration. Coursed Lias stone walls. Thatch roof with gable ends. 2 rendered stacks at left (projecting) and right hand gables. Large projecting front stack, at centre, with moulded plinth and set-offs, rebuilt 1982 with gross pointing. Plan: 3 units ground plan, with parlour and hall at centre. Original entrance, not ascertainable. 2 storeys. 4 windows, 3 light C20 metal casements with glazing bars. Wooden frames and mullions. 2 small single windows, either side of stack (first floor), with leaded lights. Front door at right hand end of south front, C20 wooden studded door. Hipped thatch canopy over. Large outshut at rear, under gentle pitch taken from ridge. Rendered walls and a tile roof. Small canted oriel. Interior: hall with heavily moulded ceiling beams comprising 16 compartments. Joists running in opposing directions in each cell, C16. Stone fireplace, C19 in Tudor style. "RCHM, Dorset I," p 95 (7).

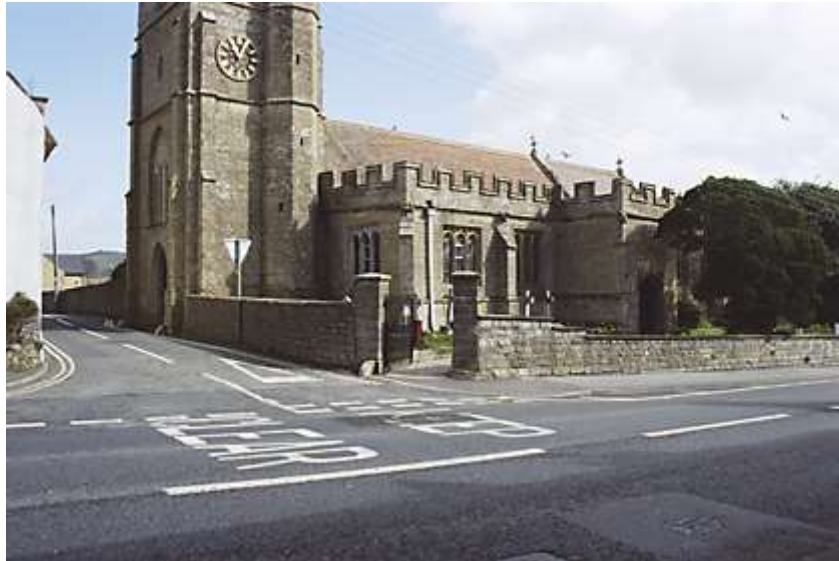
IoE Number: 400575

SY 4292 CHIDEOCK MAIN STREET NORTH SIDE 9/51 Churchyard Wall bounding west side of yard, Chideock Church G.V. II Churchyard wall, attached to west tower and running 25 metres north of tower and 10 metres south of tower, C17. Rubble-stone with flat stone coping, standing to about 5 feet. Gate piers into churchyard at corner with main road are included.

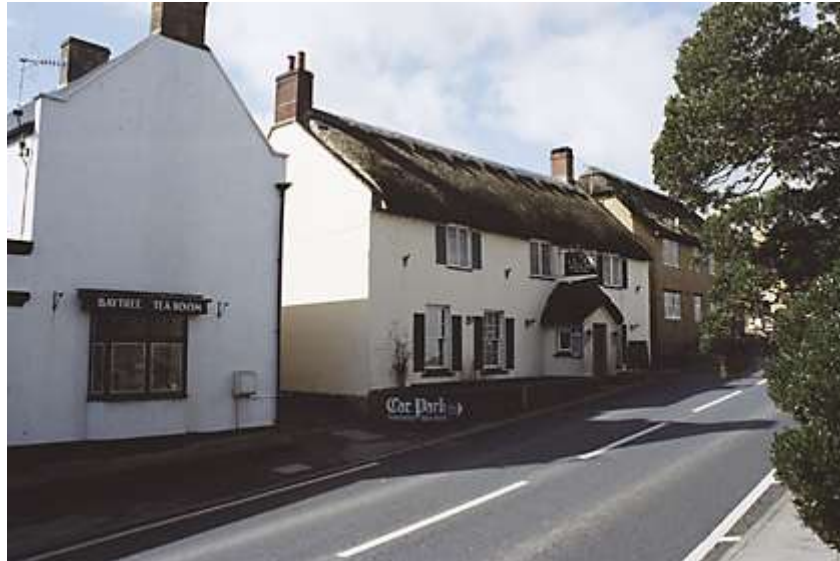
IoE Number: 400819

SY 4292 CHIDEOCK MAIN STREET SOUTH SIDE 9/75 Clock House Hotel 5.9.60 - II Hotel. c.Late C17 with an C18 reface. Stone walls, rendered. Thatch roof with gable ends and block ridging. Stone gable copings at left and right hand gables. Brick stacks at each gable end. 2 storeys. 3 windows, ground floor with sashes and window shutters. First floor has 2-light wooden casements with shutters. Front door, right of centre, wood. Rendered porch with a half-hipped thatch roof. Wooden studded door.

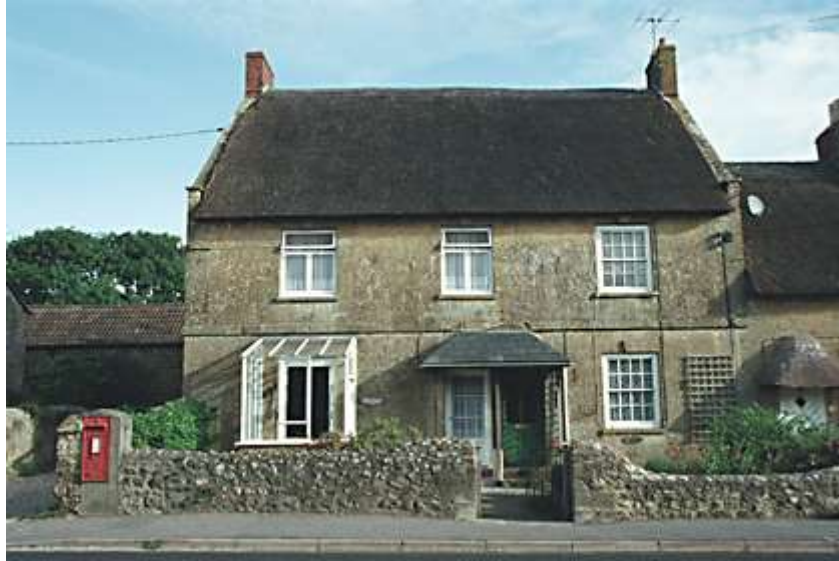
IoE Number: 400654

SY 4292 CHIDEOCK MAIN STREET NORTH SIDE 9/65 Hill View and Fernley G.V.
II Two cottages in formerly one house (attached to east). c.1810. Ashlar lias stone walls, with a stone plat band dividing the storeys. Thatch roof with gable ends and stone gable copings with level kneelers. Two C20 brick stacks at left and right hand gables. 2 storeys. 3 windows, sashes with glazing bars at right, C20 wooden casements at left. Stone cills and projecting keys to all windows. 2 front doors, one at centre (original position), wooden C20; one immediately right of centre, wooden early C20. Simple porch canopy oven carried on light posts.

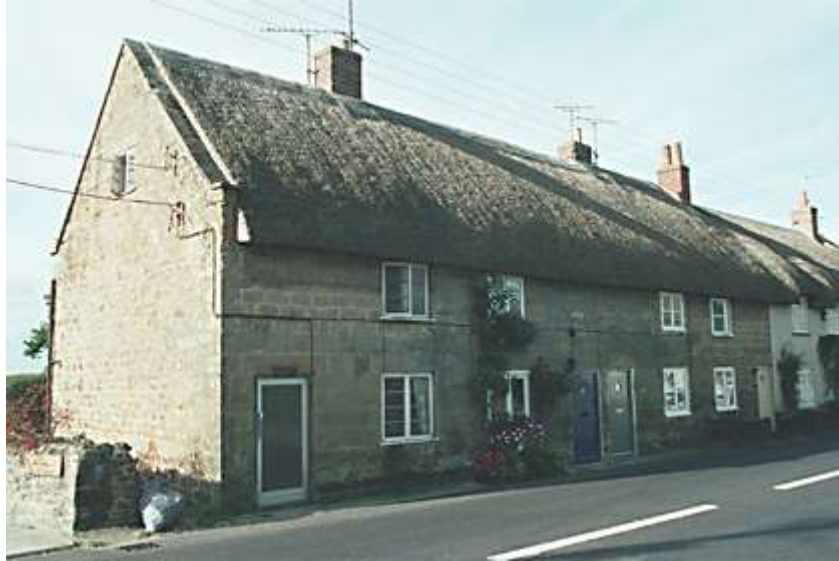
IoE Number: 400750

SY 4292 CHIDEOCK MAIN STREET SOUTH SIDE 9/71 Ivanhoe, Ashton, Hasted Cottage and 5.9.60 Berrycot G.V. II Four attached cottages. c.Mid C18. Coursed lias stone walls. Thatch roof with stone gable coping at left hand, continuous into right hand property. 2 brick stacks: at ridge, at party walls. 2 storeys. 4 windows, with key-stones, wooden casements, some with small glazings, wooden cills. Front doors, left to right: (1) C20 with big glass panel; (2) C19, plank; (3) C20, wood with one large glass panel; (4) C20 metal with 2 glass panels.

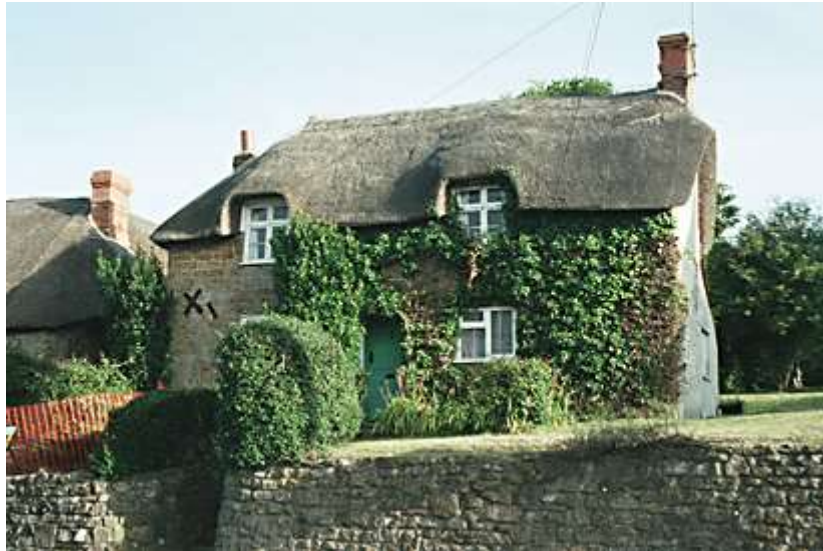
IoE Number: 400597

SY 4292 CHIDEOCK MAIN STREET NORTH SIDE 9/57 Ivy Cottage 5.9.60 G.V. II
Single cottage. Later C18. Lias stone walls Thatch roof, hipped at left hand, gabled at right hand. 2 C20 brick stacks, one at left eaves, one at right gable. 1½ storeys. 2 windows. C 20 2 light wooden casements with wooden cills. Flush stone keys over. Front door, roughly at centre, with flush and recess panels, c 1800. Continuous C20 outshut at rear, rendered with a tile roof.

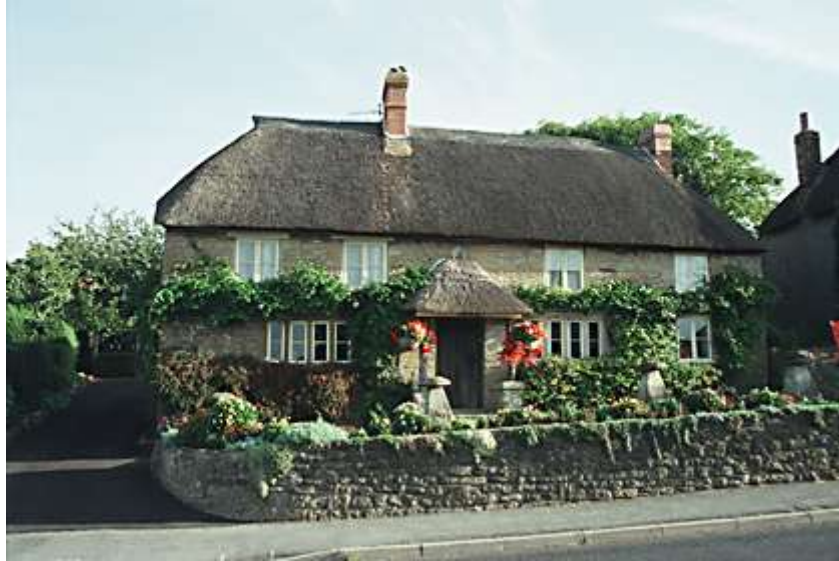
IoE Number: 400596

SY 4292 CHIDEOCK MAIN STREET NORTH SIDE 9/56 Japonica Cottage 7.8.52
G.V. II Single cottage, C16 core, C17 alterations. Coursed Lias stone walls, hipped at both ends. Two C20 brick stacks, one backing on to cross-passage, one below right hand hip apex. 2 storeys. 4 windows, ground floor with two 4-light hollow-chamfered mullions, with returned labels over. Upper windows with 2-light wooden casements and wooden cills. Very small triangular-headed window over front door. Front door, C20, plank with chamfered wooden lintel over, slightly left of centre. Hipped thatch canopy carried on wooden posts. Curving cob wall at right hand end. Interior: 2 jointed cruck trusses visible with pegged cruck-spurs. One set of heavy through purlins visible, C16. Left hand room has deep-chamfered ceiling beam with heavy filleted stops. "RCHM, Dorset I", p 95 (6).

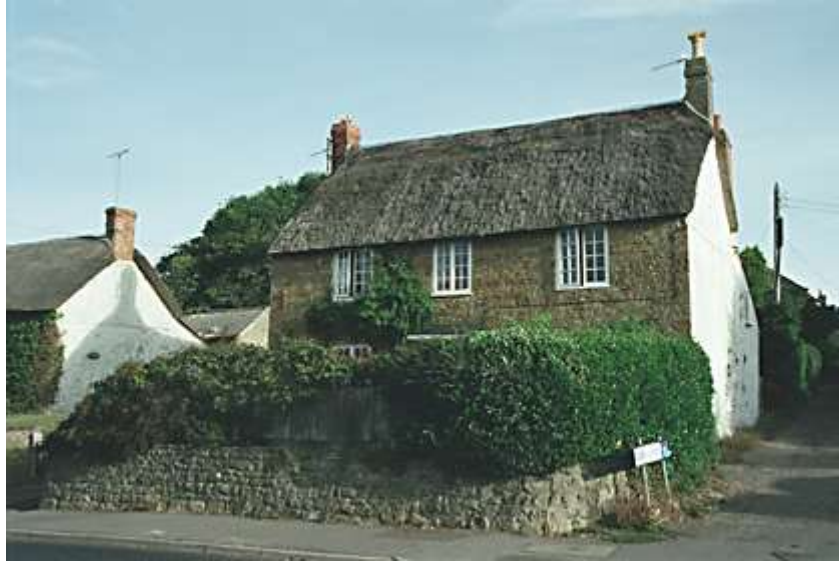
IoE Number: 400598

SY 4292 CHIDEOCK MAIN STREET NORTH SIDE 9/58 Lilac Cottage 5.9.60 G.V. II
Single cottage, c.1800. Coursed, squared Lias stone walls. Thatch roof with gable ends. 2 C20 brick stacks at left and right hand gables. 2 storeys. 3 windows, 2 light wooden casements with glazing bars. Mostly old glass survives. Wooden cills. Stone voussoirs over. Front door at centre, c 1800, wood with flush panels and 2 top lights. Very small rear wing, rendered with metal casements under a hipped thatch roof, probably a later extension.

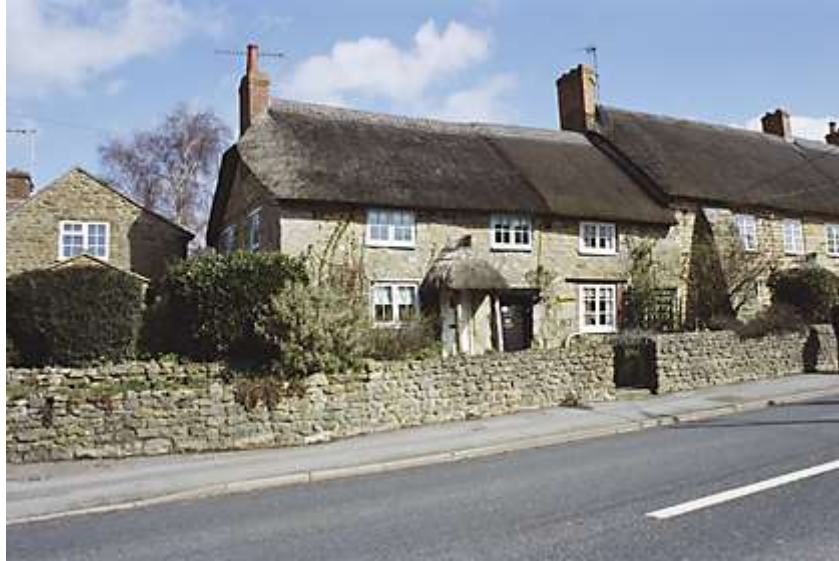
IoE Number: 400650

SY 4292 CHIDEOCK MAIN STREET NORTH SIDE 9/61 May Cottage and 5.9.60 Winniford Cottage. G.V. II Two attached cottages. C17, with later refenestration. Coursed Lias stone walls. Thatch roof with gable end at left hand and attached at right. One C20 brick stack at left gable. 2 storeys. 3 windows, enlarged wooden case-ments (2 lights) to ground floor. Small 2 light wooden casements above, -all with glazing bars. 2 upper windows in the west gable wall, with wooden lintels. Front doors, beside each other, at centre. Loft with C20 recess-panel door. Hipped thatch canopy over carried on wooden posts. Right with a wide plank door and heavy wooden lintel over. Interior: Winniford has plank and muntin partitions on both sides of a cross-passage, c.1600. Open fireplace in room on right, stone Jambes, chamfered with segmental lintel, stop-chamfered. Mid- chamfered beam with unusual roll-and-tongue stops.

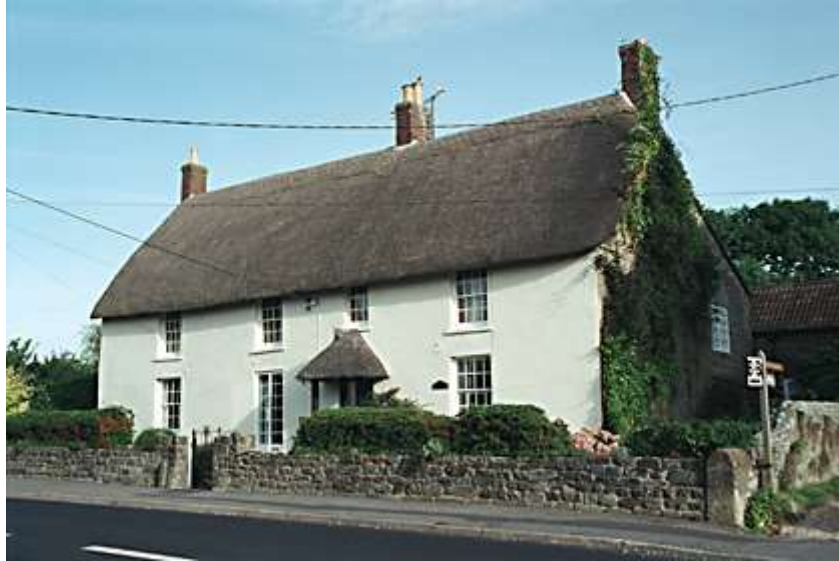
IoE Number: 400653

SY 4292 CHIDEOCK MAIN STREET NORTH SIDE 9/64 Park Farmhouse G.V. II
Single house. c 1800. Stone walls, rendered and washed yellow. Thatch roof with gable ends. 3 brick stacks, at left hand, gable, backing on to cross- passage, at right hand gable. 2 storeys. 4 windows, sashes with thin glazing bars. Crown glass. One C20 metal framed French window at ground floor. Front door, right of centre, with flush and recess panels and 2 top lights. Hipped thatch canopy carried on wooden posts. Roof pitch flatter at rear over a continuous outshut. Rubble stone walls with small wooden casements.

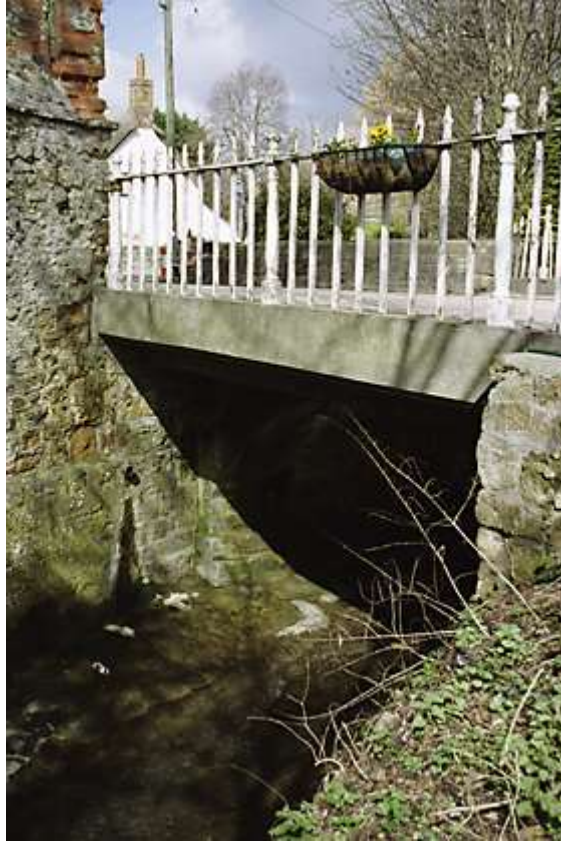
IoE Number: 400840

SY 4292 CHIDEOCK MAIN STREET 9/76 Road Bridge over river Winniford G.V. II Bridge. Early C19. Stone walls with single segmental arch, with voussoirs dying into the abutments. Attached ford surface of cobbles beneath the bridge, visible between the abutments. Modern road bridge on top of old bridge, not listable. Cast iron railings with arrow-heads and finials, forming balustrade, early C19.

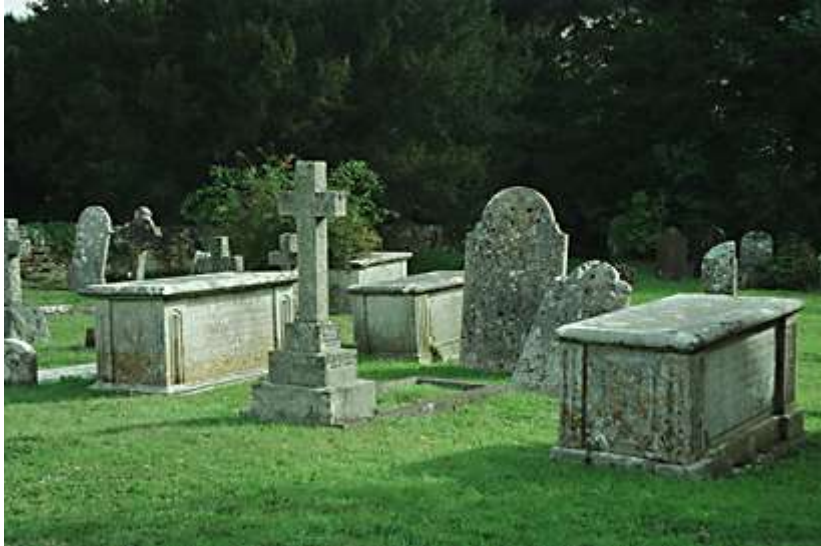
SY 4292 CHIDEOCK MAIN STREET NORTH SIDE 9/50 Table Tombs c 10 metres north and east of Chideock Church G.V. II 5 Table Tombs. (1) Immediately east of chancel. To Thomas Daniell, Steward of Chideock Manor. Stone with round-arch panels and modillions, 1668. Brass plate added 1885 by Sir F Weld. (2) To Henry Roper, d. 1780, with fluted pilaster corners and stone plinth. (3) To Giles Roper, d. 1814 with ogee-headed Indian-style pilaster corners and moulded top. (4) and (5) both early C19, overgrown and with illegible lettering.

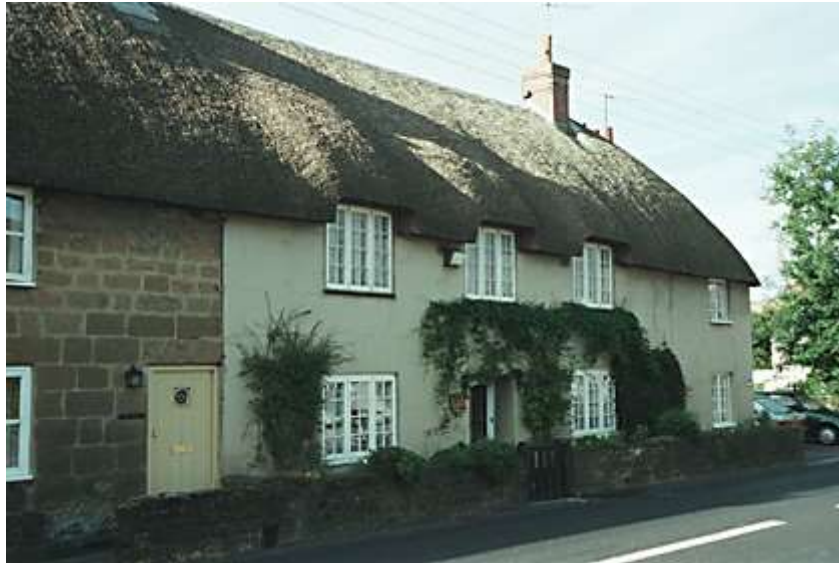
SY 4292 CHIDEOCK MAIN STREET SOUTH SIDE 9/72 Thatch Cottage and 5.9.60 Laneside Cottage G.V. II Previously listed as Thatch Cottage and Prester Cottage. Attached cottage. Later C18. Coursed lias stone walls, rendered and washed. Thatch roof, half hipped at right hand. 3 stacks; 2 brick, one rendered, at left party wall, at right hip apex, at right wall eaves. 1½ storeys. 4 windows, 3-light metal casements with glazing bars. Front door at centre, wood with 9 glass panels. Laneside Cottage is a small attached wing at rear. Rubble-stone walls. Thatch roof. 1½ storeys. Brick jambs to one casement window. Plank front door, with one lozenge light.

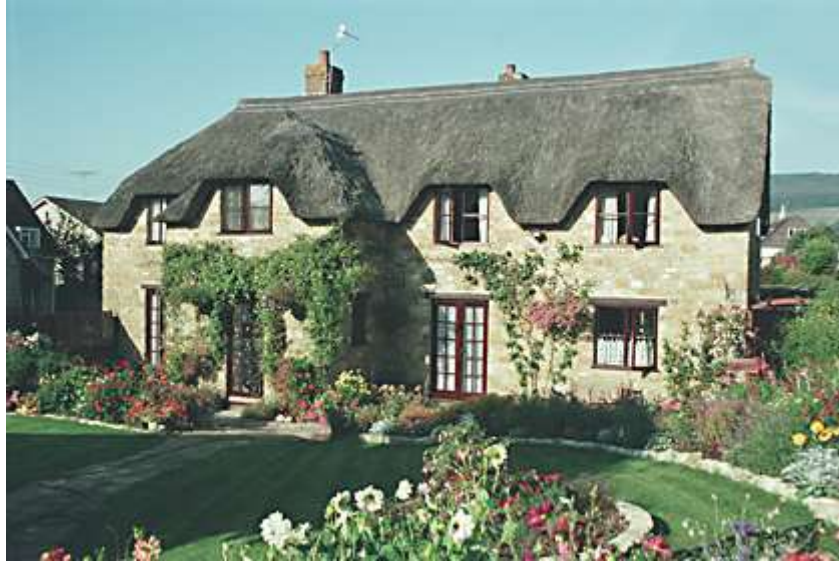
SY 4292 CHIDEOCK MAIN STREET NORTH SIDE 9/68 The Cheese House at
16.9.77 Park Farm G.V. II Cheese House. C17. Lias stone walls with large quoins to
street. Thatch roof with one gable end intact. Gable end to street has been
dismantled as unsafe. 1½ storeys. c.3 windows. Window-openings with plank
shutters, or C20 insertions. Doorway on east wall, with loft door immediately over,
plank. Thatch swept over as eyebrows. The south end of the Cheese House is in a
ruinous condition.

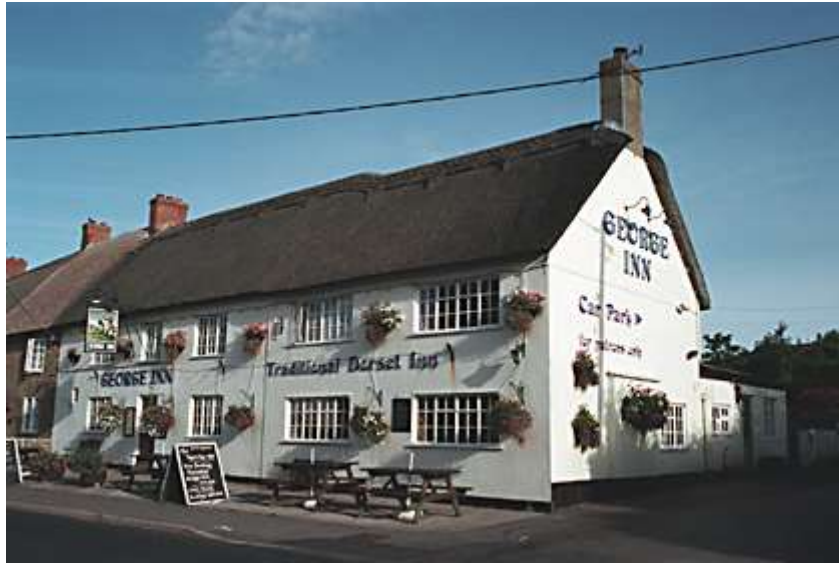
SY 4292 CHIDEOCK MAIN STREET NORTH SIDE 9/63 The George Inn 7.8.52
G.V. II Public House. Late C17, modernised. Rendered, stone walls. Thatch roof with gable end at right hand, block ridging. Ridge drops over the 2 bay C20 extension. 2 brick stacks, at left hand party wall, at right hand gable. 2 storeys. 3 windows to original house. 3 light wooden casements with glazing bars. C20 wooden cills. Front door at centre of original house, C20 plank and studded with ornamental hinges. C20 extension at right hand, same materials. 2 storeys and 2 windows with C20 metal casements of 4 lights. Interior: open fireplace in left hand room, much rebuilt.

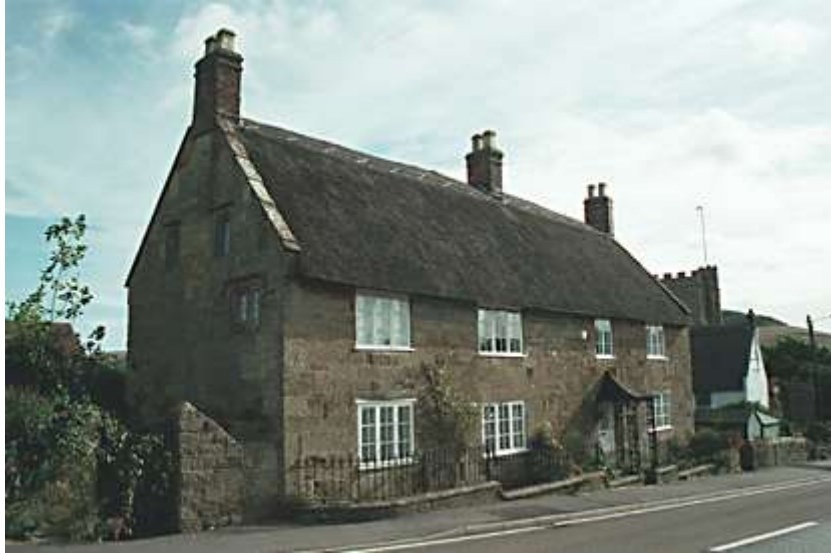
SY 4292 CHIDEOCK MAIN STREET NORTH SIDE 9/48 The Warren House, 7.8.52
formerly listed as Warren. G.V. II Single house. C17 with C18 re-fenestration. Lias
stone ashlar walls. Thatch roof of steep pitch with stone gable copings. 3 brick
stacks at: left hand gable, backing on to cross-passage, at right hand gable. 2
storeys. 4 windows, 3-light wooden casements with glazing bars. Wooden cills.
Stone lintels and keys, which project at right hand. West gable wall: 2 small attic
windows with labels over. One 2 light mullion window, labelled, lower down, C17.
Front door, right of centre, wood C20. Cast iron porch with open trellis-type supports.
Concave hipped hood over. Cast iron railings along front sleeper wall. "RCHM.
Dorset I", p 95 (11).

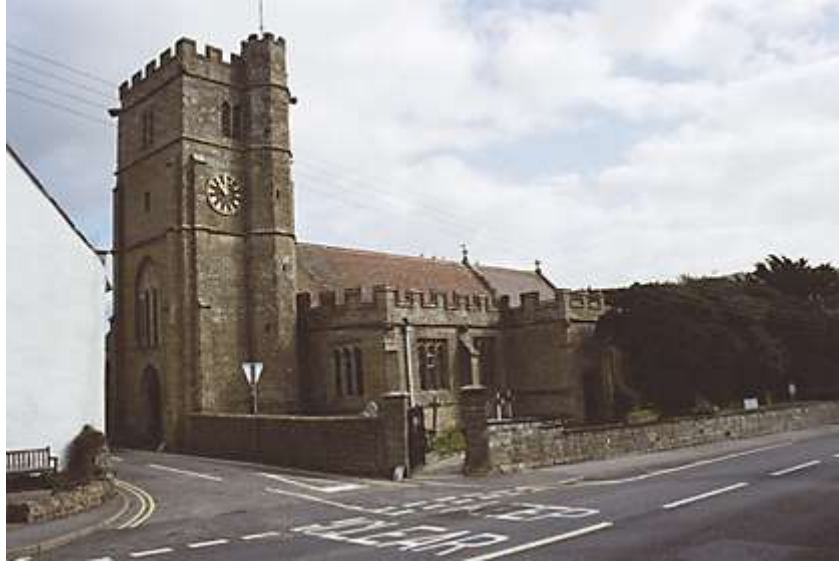
north chapel, segmental-pointed dying into the jambs, rebuilt C19. Barrel-vault. North chapel has an intersecting tracery early C14 window in north face. Chancel: of 2 bays, chancel-arch with double-keeled respond arrangement, carried into arch. Pointed wagon roof in 36 ceiled compartments. East window of 5 lights with net-panel tracery over. Side windows: 2-light, ogee-cusped under a square head, big hollow chamfers. Rere-arches. Fittings: Font, c.1500, thick octagonal panelled stem over chamfered plinth, octagonal bowl with 2 quatrefoils-in-circle sunk in each side. Cover: wood, pyramidal, with a solid finial, C17. Arundell Tomb, South chapel, Purbeck marble, early C17. Large tomb-chest with recumbent effigy of a knight in armour. 3 painted shields replace the original brass. indents. Tomb chest with turned baluster half-shrifts. 4-centred stone frame at rear of tomb. Two C13 paintings of the Church and Street, showing medieval chancel. Pulpit, 1880, hexagonal on a trumpet-stem, with panelled sides. Choir-stalls, wood, 1880. Stone piscina in south aisle, trefoil cusped under a pointed arch, C19. "RCHM, Dorset I", p 93 (1).

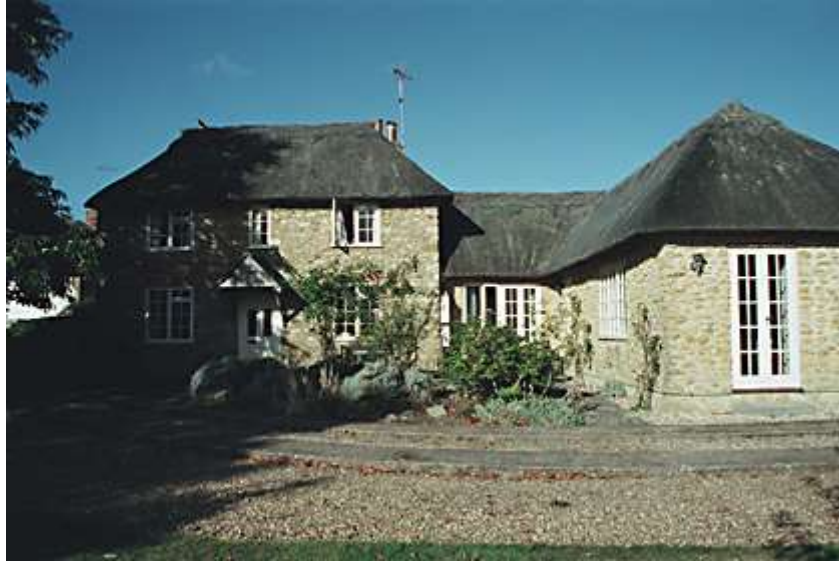
SY 4292 CHIDEOCK MILL LANE 9/78 Dawn Cottage 5.9.60 G.V. II Single cottage. Later C18. Lias rubble-stone walls, part rendered. Hipped thatch roof. 2 tall brick stacks at rear wall eaves. 2 storeys. 3 windows, 2 light C20 wooden casements with glazing bars. Wooden cills. Simple brick voussoirs over. Front door at centre, 2 leaf, wooden with flush panels and 2 glass lights over. Pentice wooden canopy over. Outshut at right hand, rendered with hipped thatch roof. 2 leaf plank door and one window either side.

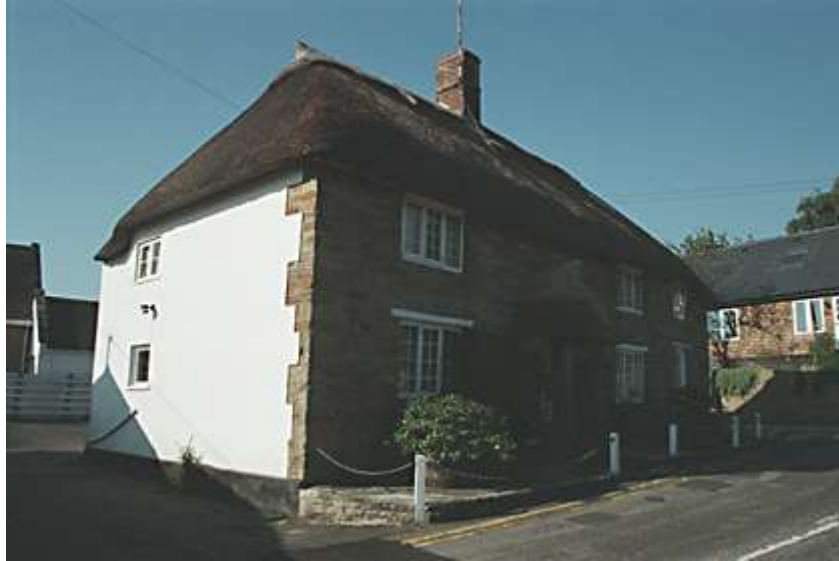
SY 4292 CHIDEOCK MILL LANE 9/77 Roadstead Farm and 7.8.52 Attached wall, along Sea Hill Lane G.V. II Single house, former farmhouse. C17, with re-modelling. Coursed rubble-stone walls with emphatic repointing. Thatch roof, hipped at both ends. Brick stack at centre. 2 storeys. 3 windows, 3 light casements with some leads and wood glazing bars. Wooden lintels over. Front door, left of centre, with flush panels and 4 glass lights, c.1800. Hipped thatch porch canopy over on 2 wooden posts. C20 frosted glass panel door at right side. Attached wall, c.14 feet high and 20 yards long, along Sea Hill Lane. Rubble- stone with freestone coping. "RCHM Dorset I", p 96 (13).
