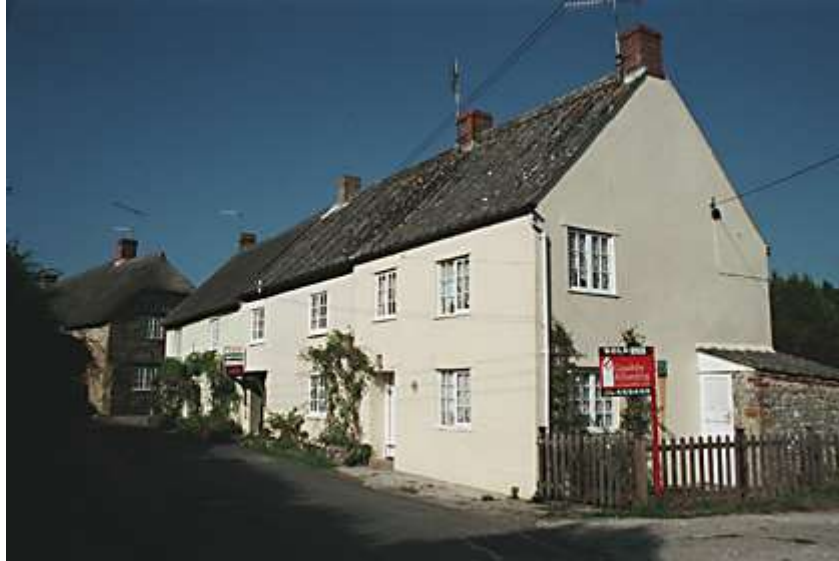
SY 4292 CHIDEOCK MILL LANE 9/80 The Cottage and 5.9.60 Trimm Cottage (The
Cottage previously listed) G.V. II Two attached cottages. Later C18. Lias rubble
walls, rendered and washed. Thatch roof (The Cottage), corrugated asbestos roof
(Trimm Cottage). 4 brick stacks at ridge, left gable, party wall, right centre, right
gable. 2 storeys 6 windows, 2 light wooden casements with glazing bars, wooden
cills. Front doors: (The Cottage) wooden, 6-panelled, at centre, C18. (Trimm
Cottage) wooden, plank with simple flat canopy over, on 2 brackets, at left. Right
centre, plank with modern pentice porch over.

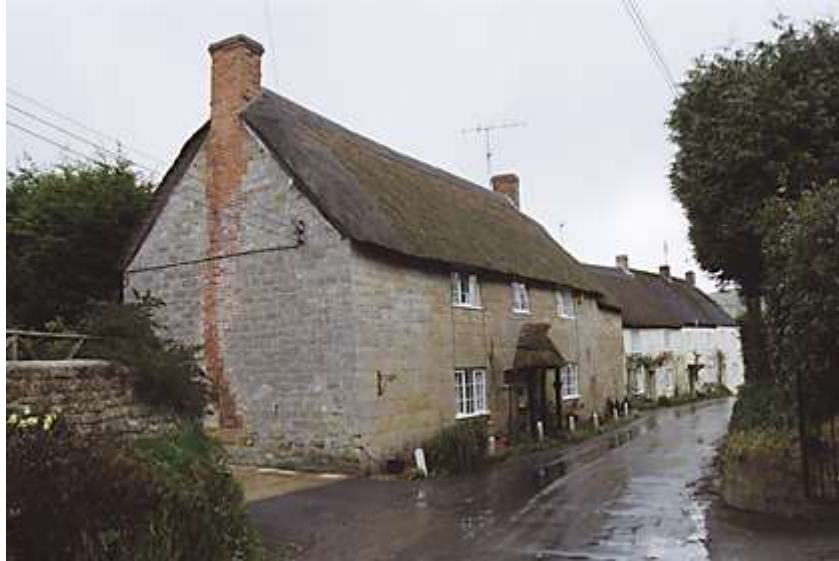
SY 4292 CHIDEOCK KILL LANE 9/79 The Farmers Arms G.V. II Single house, formerly Public House, Later C18. Coursed, dressed stone walls. Plinth. Thatch roof with gable ends. Brick stacks at left and right hand gables with moulded cornices. 2 storeys. 3 windows, 3 light wooden casements and glazing bars. Old glass. Flush keystones. Front door at centre, plank with strap-hinges, and wooden frame. Hipped thatch porch roof over, supported on square wooden posts.

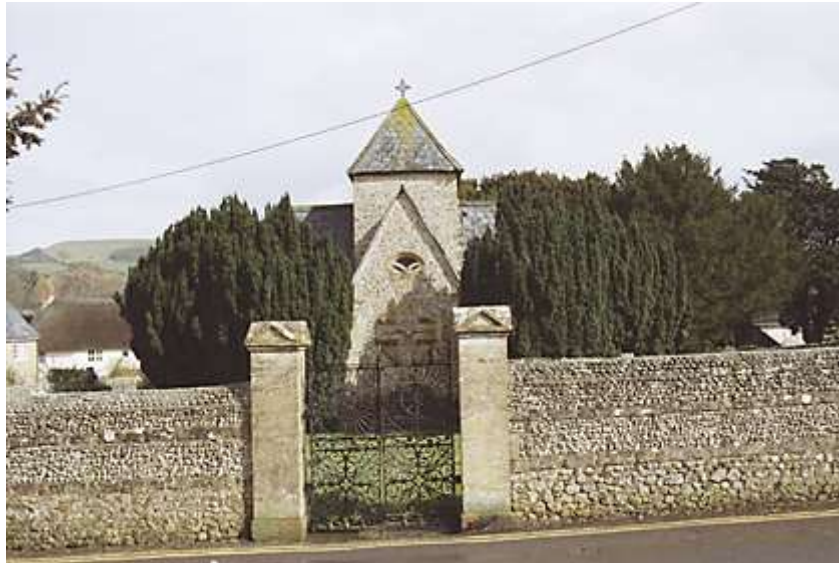
SY 4292 CHIDEOCK NORTH ROAD 9/82 Mortuary Chapel (Roman Catholic) G.V. II
Mortuary Chapel. Latin inscription with date 1857. Cruciform, small and steep.
Rubble stone walls with diagonal buttresses and set-offs. Plinth. Plain and fish scale
slate roofs of steep pitch. Central roof, of pyramidal form; tall gabled roofs to the
arms, with window-openings (eg mandorla) in the gables. 2 lancets in eastern arm.
North doorway with shouldered arch and straight- chamfered jambs. Large cross of
brick headers in east wall with lozenge stone centre with Papal insignia; Alpha and
Omega. Low relief stone rood (Christ Crucified) on west wall, in quasi-late
Carolingian style. INRI over and 2 doves and lamb. Foliage and nail-head ornament
in the spandrels.

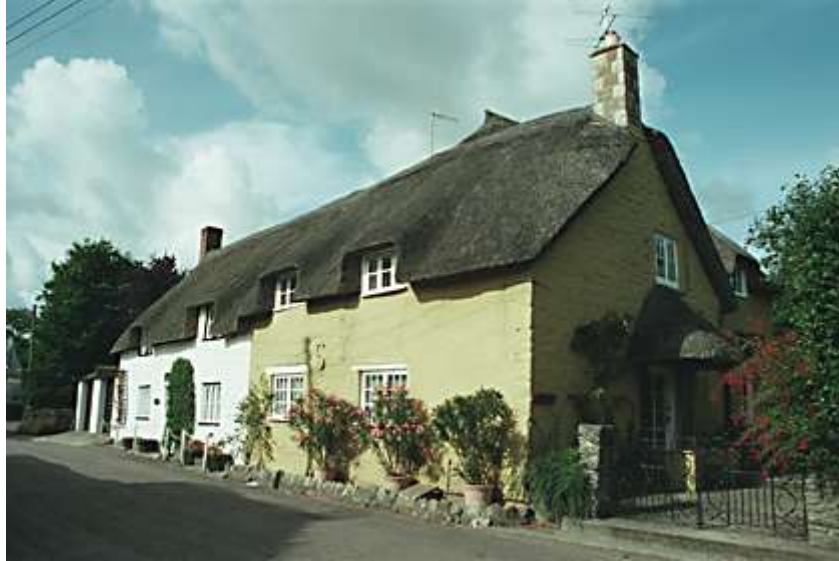
SY 4292 CHIDEOCK SEA HILL LANE 9/83 Anvil Cottage and Cob Cottage, formerly 1 and 2 Cob Cottage 5.9.60 G.V. II Two attached cottages. c 1700. Stone and cob walls, rendered and washed. Thatch roof with gable ends. Brick stack at left hand gable, C20 stone stack at right hand gable. 1 ½ storeys. 4 windows. Anvil: with 3 light casements and wooden cills. Old glass. Cob: with 2 and 3 light casements with glassing bars. Front doors: Anvil, at centre C20 plank with wood framing. Cob, on gable wall, C20 with glass panels. Thatch porch canopy over. Right angle extension at rear of Cob. "RCHM, Dorset I", p 96 (15, 16).

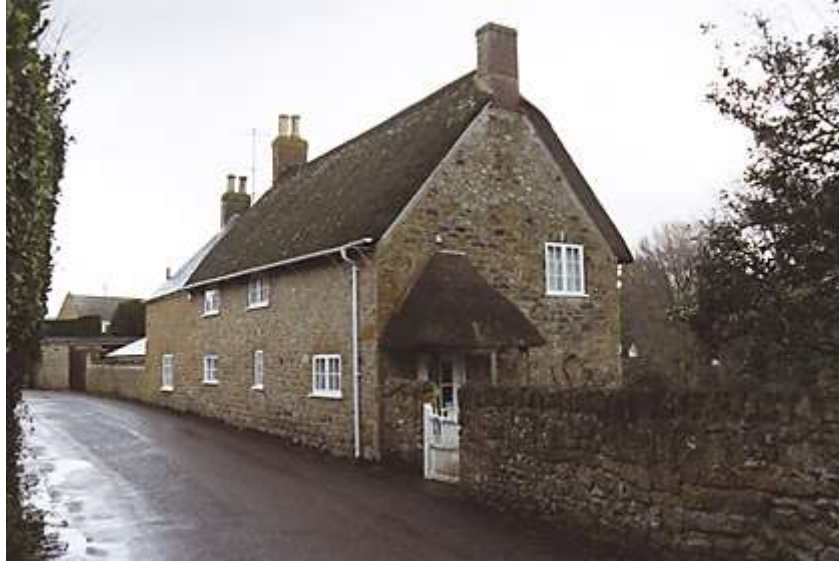
SY 4292 CHIDEOCK SEA HILL LANE 9/84 Vine Cottage, with attached stone walls. G.V. II Single cottage. c.C18. Lias rubble walls, roughly coursed; large stone quoins. Slate roof at left hand bay. Thatch roof, remainder, with gable ends. 3 brick stacks, at far left gable, inner thatch left gable, right gable end. Lane elevation. 2 storeys. 4 windows, 2 light wooden casements with glazing bars. Wooden cills. Front door in south gable wall, C20, wooden with 8 glass panels. Hipped thatch porch canopy over, supported on 2 wooden posts. Attached stone rubble walls, 7 yards north and 10 yards south, making a continuous stone frontage to the lane. "RCHM, Dorset I", p 96 (14).

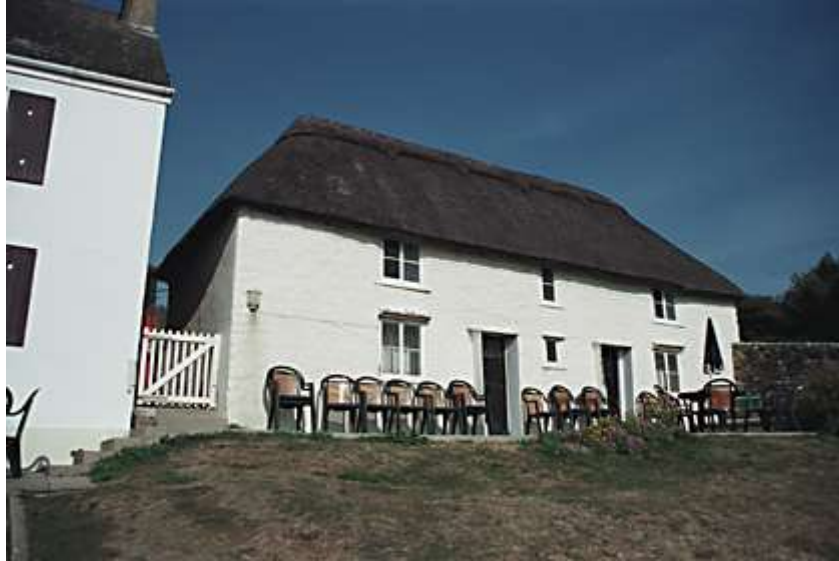
SY 49 SW CHIDEOCK SEATOWN 6/104 Anchor Cottage - II Single cottage, formerly two. C18. Rubble-stone walls, washed. Thatch roof, hipped at both ends. No stack visible. 2 storeys. 3 windows, 2-light wooden casements and cills. 2 front doors to left and right of centre, plank with glass lights at the top.

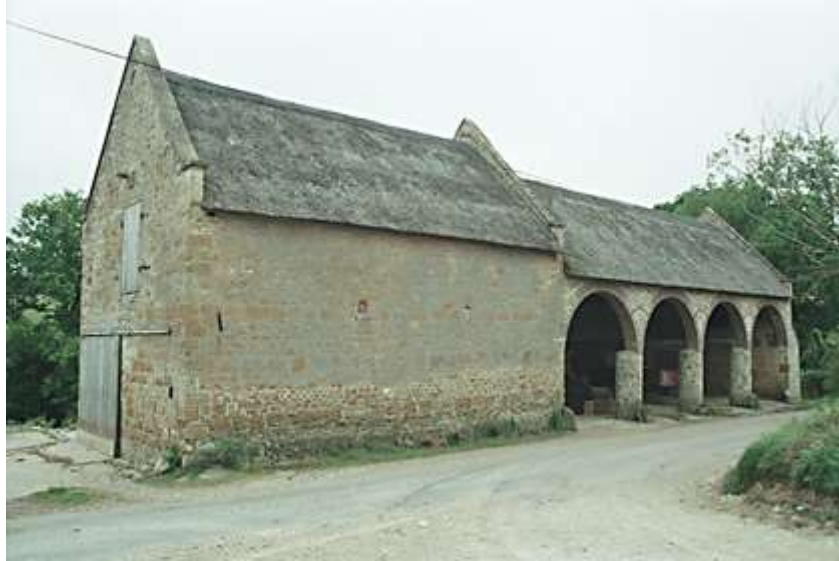
SY 49 SW CHIDEOCK NORTH CHIDEOCK 6/93 Barn and Cart Shed 150 metres west of Silverbridge farmhouse - II Barn. C18. Rebuilt gable end with the datestone 1846. Coursed lias stone and rubble stone walls, evenly banded. Thatch roof, with gable ends and stone gable copings to barn and lower cart shed. Barn taller than cart shed. Pitch door in east gable. Enlarged opening in east wall. Attached cart shed, C17. 4 bays. 3 large rubble-stone piers to north (open) side. Brick round arches over with flush rubble-filled spandrels. Heavy tie-beams from top of piers and bedded into rear wall. Roof construction, collar-beam trusses with renewed butt-purlins and plated yokes. "RCHM, Dorset I", p 96 (21).

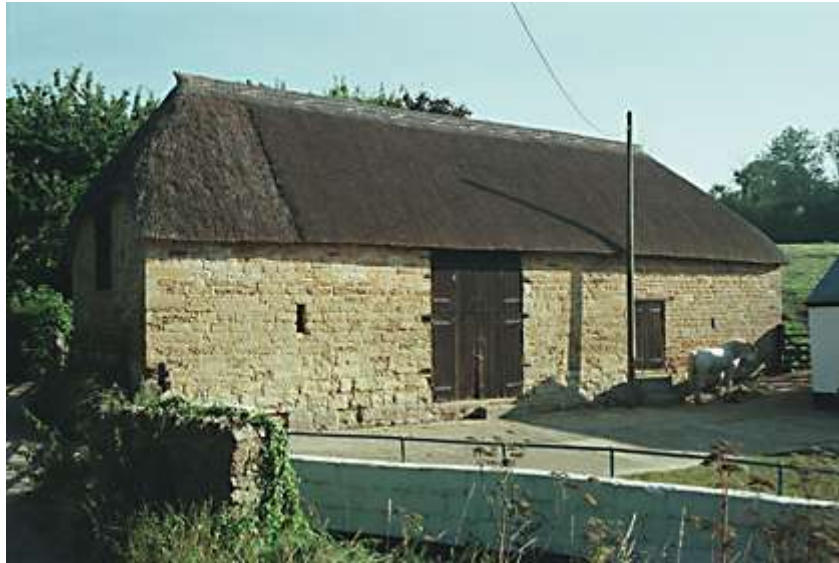
SY 49 SW CHIDEOCK NORTH CHIDEOCK 6/91 Barn at The Hollow G.V. II Barn, c 1700. Coursed lias rubble walls, with a straight joint to right hand side. Thatch roof, half-hipped and gabled. One storey. Barn door at centre, 2-leaf plank over raised plank floor. Small plank door to right hand with wooden lintel over, (separate store room). Loop to left of barn doors. Gable end with 2 round ventilation holes, now blocked internally. Pitch door over.

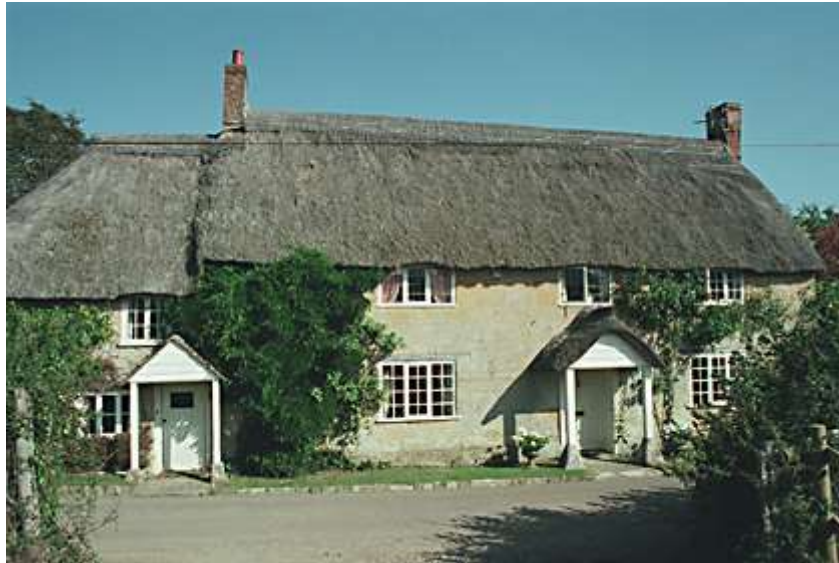
SY 49 SW CHIDEOCK NORTH CHIDEOCK 6/101 Champs land - II Single house, late C17. Ashlar lias stone facade. Rubble stone at left hand bay (former Dairy). Thatch roof, hipped at left hand, gabled at right hand. Renewed brick stack at left hand hip and right hand gables. 2 storeys. 3 windows and additional 2 at left hand. Renewed 3-light wooden casements and glazing bars. Wooden cills and lintels. Upper floor windows with small leaded lights. Front door, right of centre, wood with 6 recess panels. Thatched gabled porch with weather-boarded front and carried on 2 wooden posts. Left door, plank with strap-hinges and heavy wood frame. Interior: ceiling beams, mid- chamfered with filleted stops. Large open fireplace with wooden lintel over. Dairy with heavier chamfered beams, with filleted stops. Window shutters throughout with recess-panels.

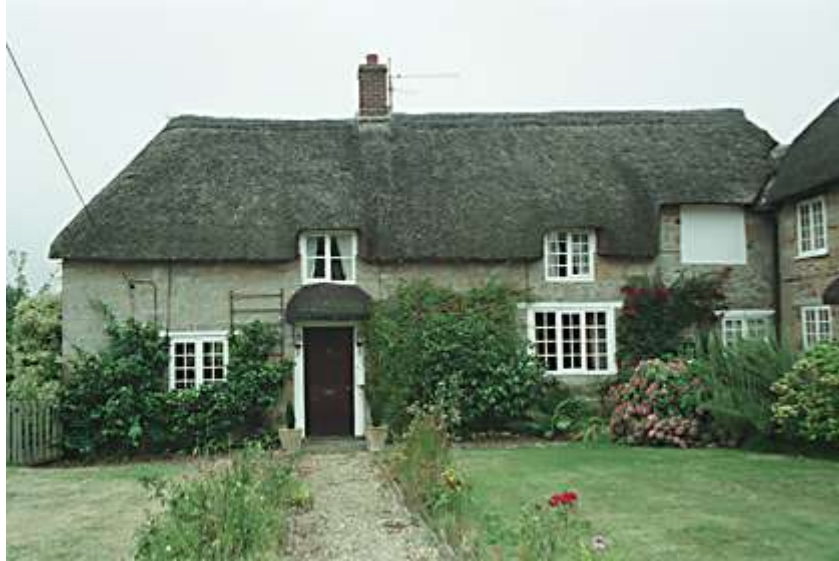
Location: DORMER COTTAGE,
CHIDEOCK, WEST DORSET, DORSET

SY 49 SW CHIDEOCK NORTH CHIDEOCK 6/97 Dormer Cottage G.V. II Cottage, attached at right angles to ThreeWays at one corner. C15 core with early C17 ceiling of a small open-hall. Lias stone walls. Thatch roof hipped at left hand, gabled at right hand. One brick stack at ridge, backing on to cross-passage. 1½ storeys. 4 windows, 2-3 light wood case-ments, with glazing bars. Wooden lintels. Half-dormers to upper floor with thatch swept over. C17. 3 light leaded wooden casement with central opening and 2 fixed. Opaque glass. Front door, left of centre, wooden with flush panels, c C19. Square plank pitch door, upper right, originally to a small loft. Interior: roof of jointed-cruck construction, originally with collars. One truss visible, 2 in partition walls. 2½ bays of Open Hall formerly. 2 sets of through-purlins. Ground floor ceiling has deep-chamfered beams with filleted stops. C17,

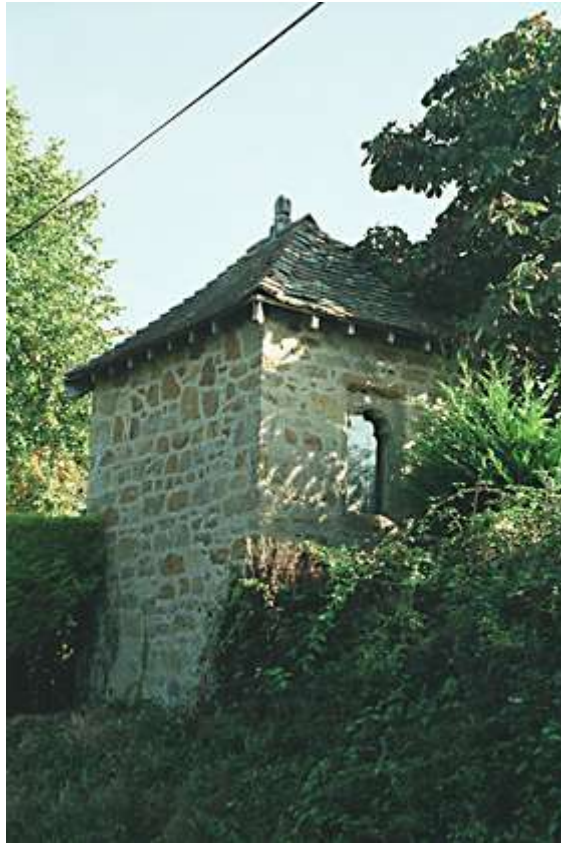
Location: GARDEN HOUSE, 50 METRES NORTH OF GATE FARMHOUSE,
CHIDEOCK, WEST DORSET, DORSET

SY 49 SW CHIDEOCK NORTH CHIDEOCK 6/86 Garden House, 50 metres north of
Gate Farmhouse. - II Garden House. C19. Very small square structure. Lias stone
walls with a pyramidal tiled roof. Round-headed entrance on north side. (No door).
South side with a trefoil-cusped window opening.

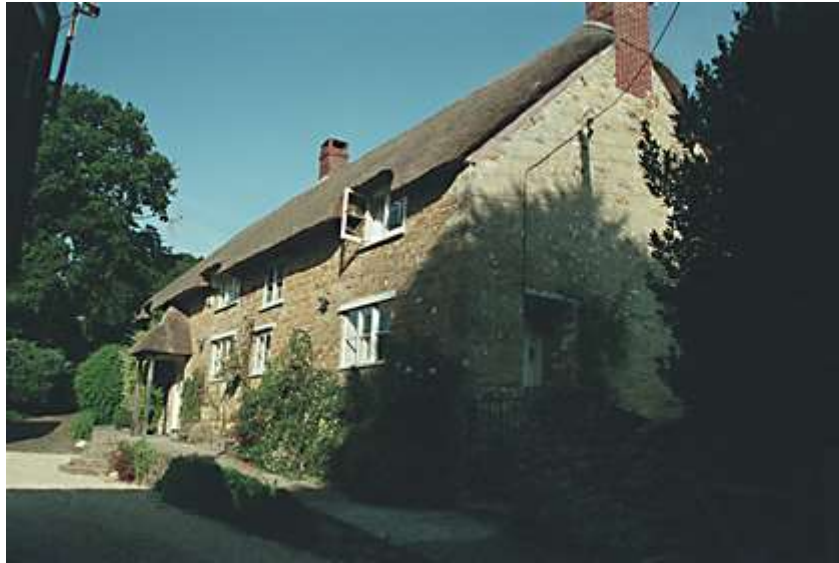
Location: GATE FARMHOUSE,
CHIDEOCK, WEST DORSET, DORSET

SY 49 SW CHIDEOCK NORTH CHIDEOCK 6/85 Gate Farmhouse - II Farmhouse. C17. Coursed rubble-stone lias walls. Thatch roof, half hipped and gabled. Renewed brick stacks, backing on to cross-passage, at right hand gable. 1½ storeys. 4 windows, 2 and 3-light wooden casements (C20), some with glazing bars. Crown glass. Wooden cills and lintels. 3 half dormers. Front door, left of centre, plank and studded C20. Hipped thatch porch canopy carried on 2 wooden posts. Raised stone pathway along front of house to front door. Interior: mid-chamfered beam with filleted stop. Blocked fireplace with segmental lintel over. Plank doors with iron hinges. "RCHM, Dorset I", P 96 (17).

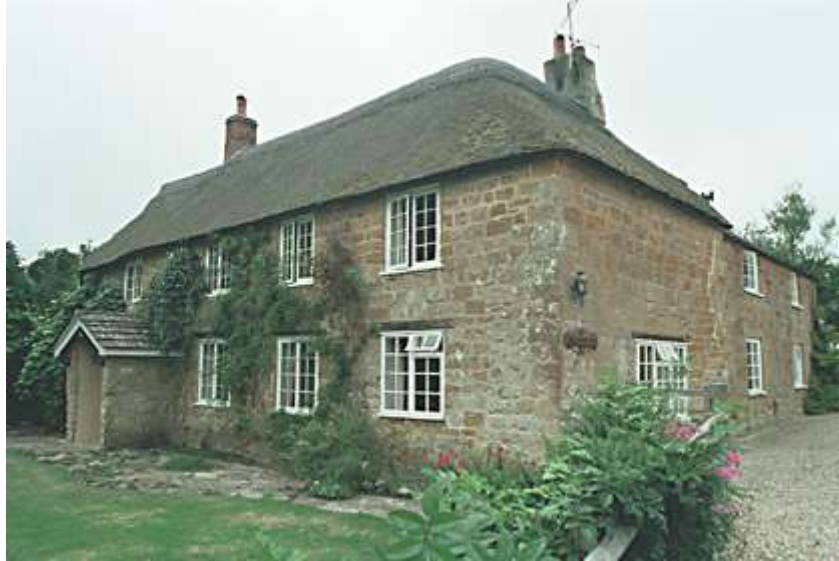
Location: HELL FARMHOUSE,
CHIDEOCK, WEST DORSET, DORSET

SY 49 SW CHIDEOCK NORTH CHIDEOCK 6/100 Hell Farmhouse - II Farmhouse, c 1700. Coursed lias stone walls and chert rubble walls. Thatch roof with gabled and hipped ends. One renewed brick stack at former left hand gable. One at former right hand rear gable. Originally a very short cross-wing. 2 storeys. 4 windows, 2-light wooden casements and glazing bars. Wooden cills and lintels. Front door towards left hand end, wood with small top lights, C20. Stone porch with pitched gable roof and concrete tiles. Rear wing has stone walls under a slate roof. C20 brick stack at west gable wall. Interior: 2 large open fireplaces with straight-chamfered wooden lintels over.

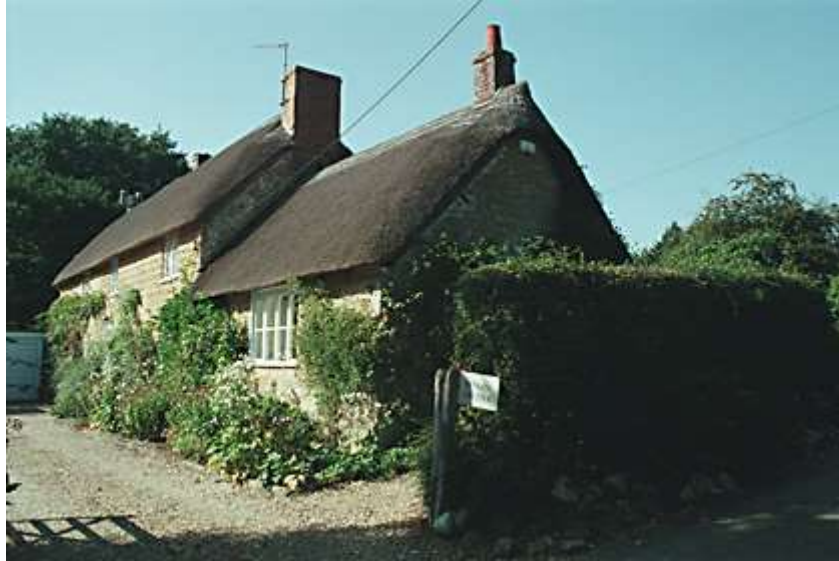
Location: HOLLOW COTTAGE,
CHIDEOCK, WEST DORSET, DORSET

SY 49 SW CHIDEOCK NORTH CHIDEOCK 6/92 Hollow Cottage G.V. II Cottage, formerly farmhouse. C18. Coursed lias stone walls. Thatch roof, gabled at each end. Lower thatch and gabled extension at right hand. 3 brick stacks, at centre behind ridge, at right inner gable, at far right gable. 2 storeys. 3 windows to main block, 2 and 3--light casements with renewed wooden cills. Large, stone voussoirs. Front door at centre, wood, 2-leaf, C20. Extension at right hand. One storey with 4 light casement window and 2 small single lights in gable end.

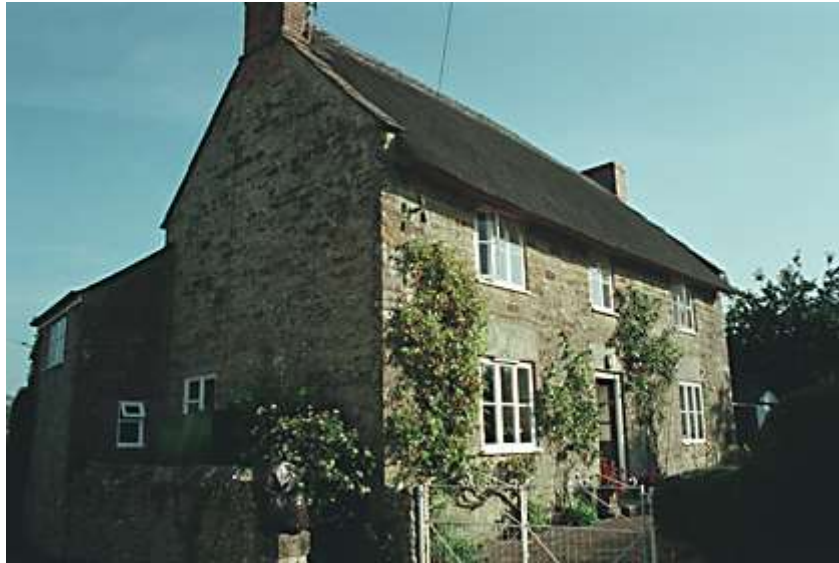
Location: LUSHAYS,

SY 49 SW CHIDEOCK NORTH CHIDEOCK 6/102 Lushays - II Single house. Early C19. Rubble-stone walls. Thatch roof with stone gable copings, corbelled. Brick stacks at left and right gables. 2 storeys. 3 windows, 3 light wooden casements. Concrete lintels over. Front door at centre, wood with glass panels, C20.

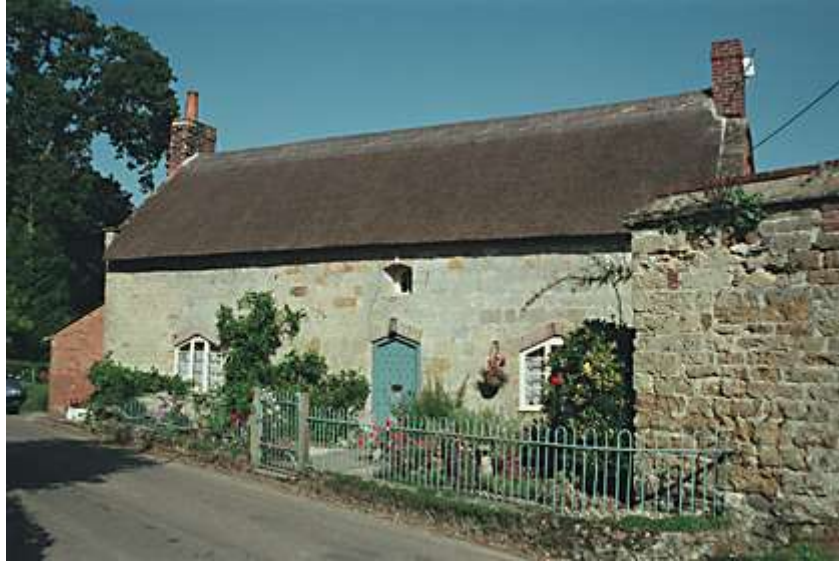
Location: MANOR COTTAGE,
CHIDEOCK, WEST DORSET, DORSET

SY 49 SW CHIDEOCK NORTH CHIDEOCK 6/90 Manor Cottage - II Single cottage. c. 1800. Ashlar stone walls at front, rubble-stone and cob at rear. Thatch roof with stone gable copings and flat kneelers. Gable ends. Brick stacks at left and right hand gables. 1 ½ storeys. 3 windows, 3 light wooden casements with straight depressed arch heads and projecting stone keys. Brick voussoirs. Small staircase with similar head. Front doorway at centre with a similar head. Plank and studded front door, C19.

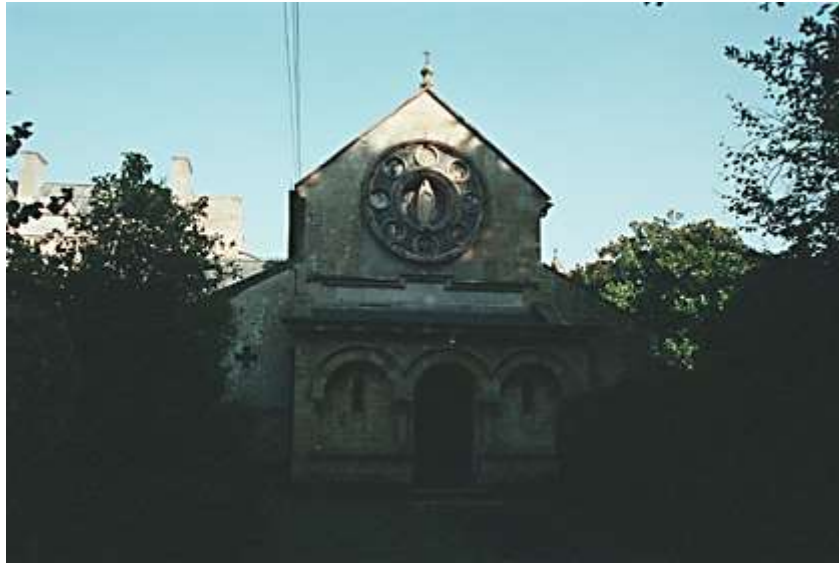
Location: ROMAN CATHOLIC CHURCH AT CHIDEOCK MANOR,
CHIDEOCK, WEST DORSET, DORSET

In the entry for:- SY 49 SW CHIDEOCK NORTH CHIDEOCK 6/89 Roman Catholic Church at Chideock Manor G.V. II [The Grade shall be amended to II*] -----
----- SY 49 SW CHIDEOCK NORTH CHIDEOCK 6/89 Roman Catholic Church at Chideock Manor G.V. II Catholic Church, incorporating former barn-chapel. C18 (barn) and church completed 1874. Barn at right angles to C19 church and forming the 'transepts' of the later structure. Basilican plan with narthex. Coursed lias stone walls. Slate roof with stone gable copings. Narthex: triple arch (2 outer blind with lancets), with continuous hood-mould over, carried on responds with capitals. Stone cill interrupted by central doorway. West gable with large terracotta roundel, painted. Virgin of the Apocalypse at centre, small roundels with scenes from Christ's Passion. Latin inscription recording the rebuilding by Charles Weld and date 1874. Nave with north and south aisles, 5 bay nave. 5 cinquefoil windows. Clerestorey lights in threes, round-arched with responds and capitals. Crossing-Tower, octagonal with sexfoil roundels in diagonals. Mansard roof over with cross at apex and heavy cornice below. C18 Barn constitutes present north and south transepts. Lias walls with gabled slate roof and stone gable coping. 5 brick arches, with keys, 2 blocked, rest windows. East gable wall with 3 niches and decorative tile work under the coping. Interior: Narthex, round-arch entrance to church, 2-leaf wood door. Inscription from Habakuk 11:20. Nave: 5 bays, short columns, carved foliage-with-motifs block capitals, eg Crown of Thorns, Symbols of Passion, Sacred Heart pierced by Cross. Low round arcade with labels and shield stops in spandrels, eg Dove with olive branch. Row of Catholic martyrs' portraits below clerestorey windows. Roof with coving and pointed barrel vault over in 40 panels. Stencil

decoration. Pointed sanctuary arch carried down on octagonal columns with Byzantine-style block capitals. Sanctuary with columns and capitals set as an octagon-in-square. Pointed arches over carry walling, pendentives, heavy cornice and circular elliptical dome with stencil decoration in the crown. East wall, stencil decoration, gilded figure of Virgin, independently lit. Fittings: Font in south west baptistery chapel, round bowl carved with quatrefoils on an octagonal stem. North west chapel with crucifix and Our Lady of Sorrows. North and south aisle chapels with stone altars carved in shallow relief. North chapel with half octagonal lit dome. Gilded figure of Christ (Sacred Heart) in alcove. Wooden altar from old chapel c 1800 with "Altare Privilegiatum" and "Hic jacet corpus S. Mecius martyris". Old chapel with former sanctuary at south end. Segmental ceiling. Wall paintings throughout with Apostles, scenes from The Life of Christ, etc. Sculptors for 1874 church, Thomas Gadsby (Dorchester) and Charles Weld. "J Brocklebank, Victorian Stone Carvers in Dorset Churches," p 43.

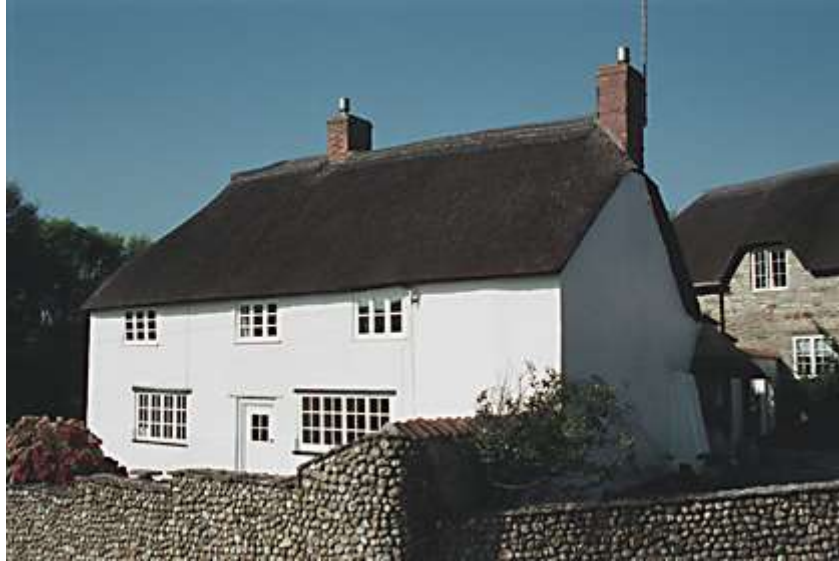
Location: SEATOWN FARMHOUSE,
CHIDEOCK, WEST DORSET, DORSET

SY 49 SW CHIDEOCK SEATOWN 6/105 Seatown Farmhouse - II Farmhouse, c 1700, with later alterations. L-plan house. Stone walls, rendered. Thatch roof, hipped at left hand. Brick stacks at right hand gable, at rear eaves below hip, at centre on ridge. 2 storeys. North-east elevation has 3 windows, 3-and 4-light wooden casements with glazing bars. Wooden lintels over. Plank door at centre with 4 glass panels, C20.

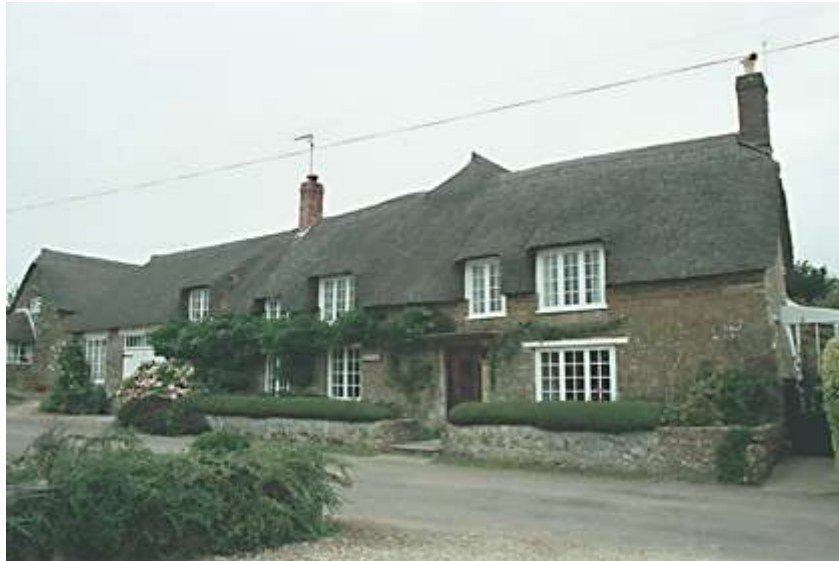
Location: SILVERBRIDGE COTTAGE,
CHIDEOCK, WEST DORSET, DORSET

SY 49 SW CHIDEOCK NORTH CHIDEOCK 6/99 Silverbridge Cottage G.V. II
Cottage, formerly farmhouse. C17, much restored. Coursed lias rubble walls. Thatch
roof with gable ends. 2 brick stacks, C20, left of centre at ridge; at right gable end.
1½ storeys. 5 windows, 2 and 3 light wooden casements and glazing bars. Wooden
cills and lintels. Half-dormers. Front door, right of centre, plank, C20. Flat stone
canopy over on moulded brackets. Rear wing at right angles from middle of range.
Rubble flint walls and brick quoins. Half-hipped thatch roof to north. Sash window in
gable end.

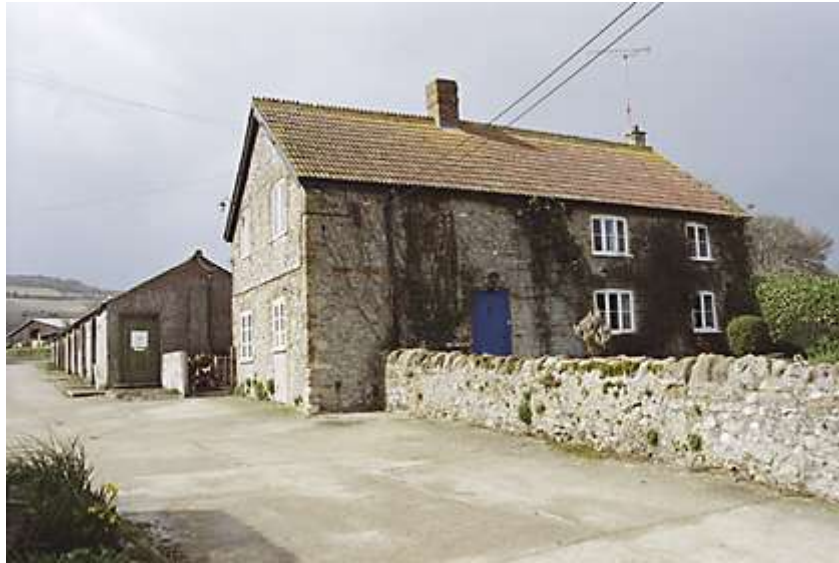
Location: SILVERBRIDGE FARMHOUSE,
CHIDEOCK, WEST DORSET, DORSET

SY 49 SW CHIDEOCK NORTH CHIDEOCK 6/94 Silverbridge Farmhouse - II Farmhouse. C17 core, C19 exterior. Chert rubble walls with stone quoins. Patent tile roof with gable ends. 2 brick stacks, left gable and left centre. 2 storeys. 3 windows, 3 light wooden casements with segmental stone arch-heads. Front door, left of centre, narrow plank. Interior: right hand ground room with deep-chamfered ceiling beams making 6 compartments. Blocked open fireplace.

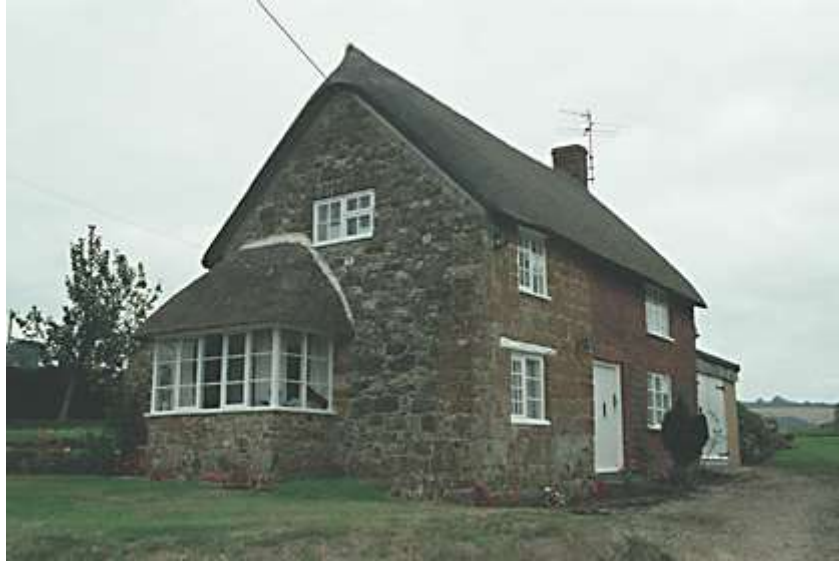
SY 49 SW CHIDEOCK NORTH CHIDEOCK 6/96 Stonebridge G.V. II Single cottage. C18. Lias stone and brick walls (Flemish bond). Thatch roof with gable ends and one brick stack at north gable. Gable end to lane. 1 ½ storeys. 2 windows, 3 and 2-light wooden casements with glazing bars. Wooden cills and lintels. Front door at centre of east elevation, plank, C20. Brick voussoirs over. Lias stone buttress and set-off at south east corner. C20 window-bay with hipped thatch canopy over to south gable wall.

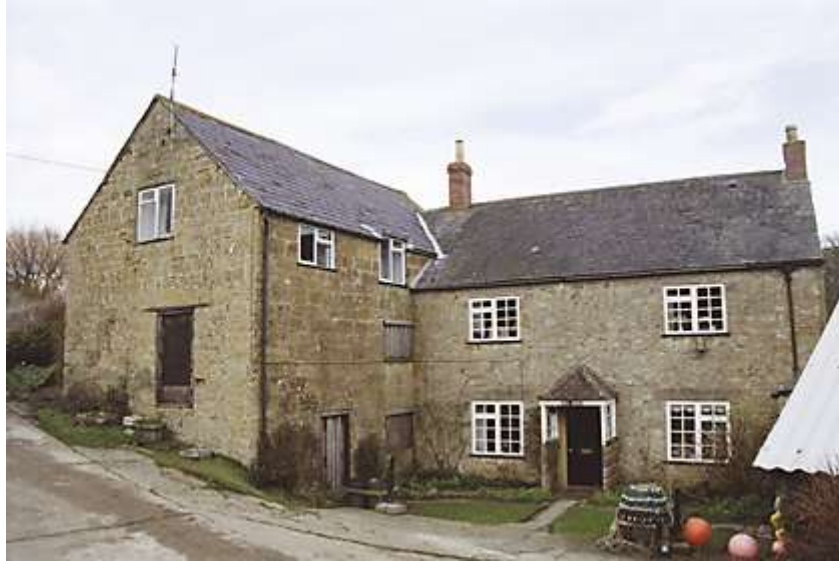
Location: THE MILL HOUSE,
CHIDEOCK, WEST DORSET, DORSET

SY 49 SW CHIDEOCK SEATOWN 6/103 The Mill House - II Mill and House at right angles. c 1800. House: coursed rubble-stone walls, slate roofs and a tiled ridge. Brick stacks at right hand gable and left on ridge. 2 storeys. 2-3 windows, 3 light wooden casements and glazing bars. Large stone voussoirs over. Wooden cills. Front door at centre, with 6 fielded panels. C 20 porch. Mill: dressed stone walls. 5 storeys, c 2 bays. Gable end to lane. Plank door with wooden lintels. Stone floor, but no machinery survives.
